PROBLEMS WITH CODE-COMPLIANT BRICK VENEER IN RESIDENTIAL CONSTRUCTION

Derek A. Hodgin, RRO, RRC, RWC, PE, CDI Construction Science and Engineering, Inc. Westminster, SC

Problems With Code-Compliant Brick Veneer in Residential Construction

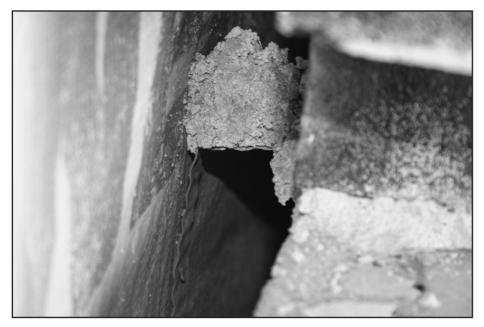
Photo 1 – Mortar droppings collect on top of metal brick ties and bridge the 1-inch air space, coming into direct contact with a highly permeable weather-resistant membrane.

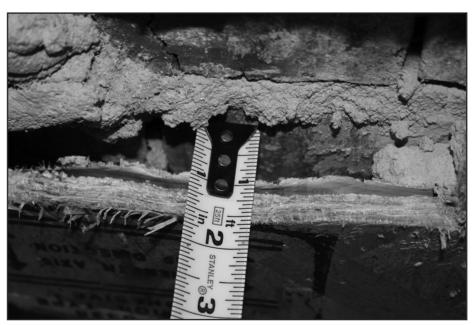
To delete the use of a weather-resistant membrane makes no sense, even in the presence of an air space. The reality of construction is that the width of the air space will vary due to imperfections in one or all of the following: wall framing, foundation, and bricklaying. The air space will also include mortar slop and droppings that collect at the base of the wall and on top of wall ties (Photo 1). The mortar will bridge the airspace, touching the unprotected wall sheathing. Therefore, even when the required 1-inch air space is planned for, it is rarely achieved (Photo 2). Additionally, the author has observed garbage (i.e., food wrappers and containers, construction debris, soda and beer cans, etc.) in the air space on numerous

Photo 2 - A typical 1-inch air space ends up being reduced due to the presence of mortar and variations in wall framing and brick alignment.

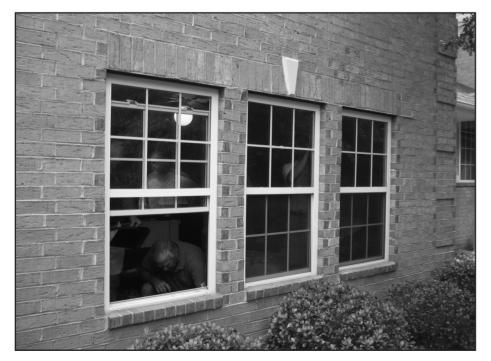
Photo 3 – Exterior view of a residential building with no obvious damage.

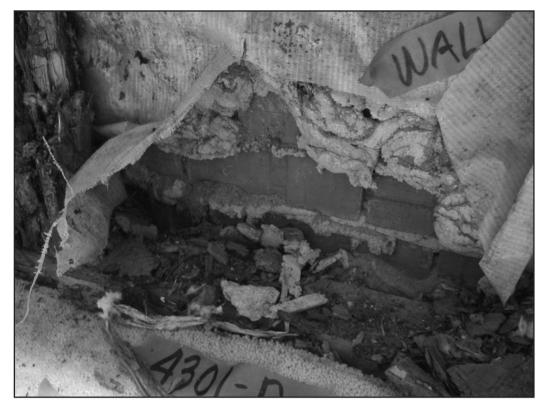
In particular, when saturated mortar is in direct contact with a highly permeable membrane, liquid water can easily pass through to the unprotected areas of the wall assembly, resulting in deterioration and mold growth. The water is able to pass through the barrier due to capillary continuity, the same process that causes an otherwise dry camper to get wet in the morning when touching the side of a canvas tent. For this reason, allowing mortar (or any other absorbent construction material) to come into direct contact with a highly permeable membrane is not a good idea.

Photo 4 – View of the interior side of the wall shown in Photo 3 that was exposed during destructive testing. Both the exterior wall sheathing and dimensional wood framing members were rotten. An interiorside vapor barrier was placed behind the interior drywall.

This problem is made much worse when significant moisture is present in the wall assembly after a summer rain shower. The rain serves to saturate the brick veneer and the mortar slop that is in contact with the high perm weather barrier. When the sun comes out, some of the moisture is evaporated on the exterior wall surface. Unfortunately, most of the moisture (approximately two-thirds) is driven toward the interior (see *Figure 1*). Add one more problem to the mix (an interior-side vapor barrier that is also allowed by the building code), and you have the potential for a disaster (*Photos 3* and 4), yet the entire wall assembly was built in accordance with building code requirements!
