StEER: Structural Extreme Event Reconnaissance Network

HURRICANE MICHAEL: FIELD ASSESSMENT TEAM 1 (FAT-1) EARLY ACCESS RECONNAISSANCE REPORT (EARR)

Released: October 25, 2018
NHERI DesignSafe Project ID: PRJ-2111

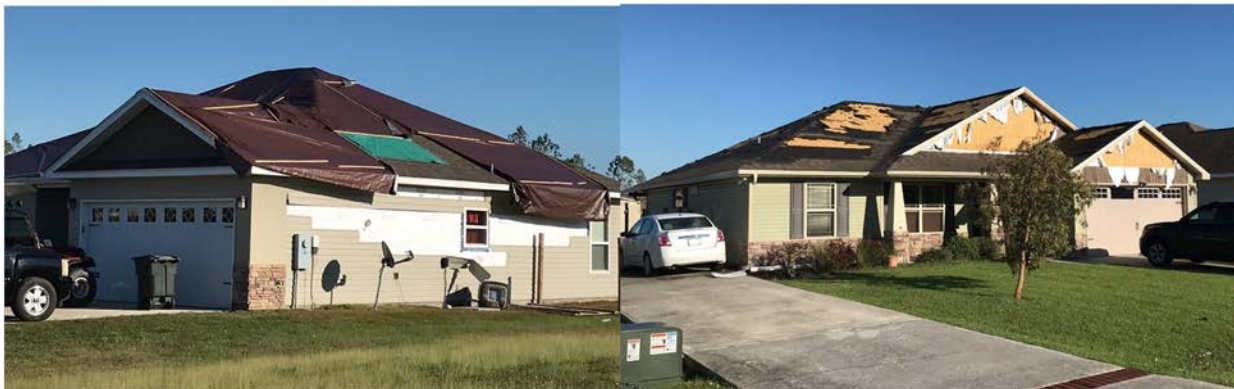
Figure 10: Damage to roof cover and building wall envelope observed in Southport

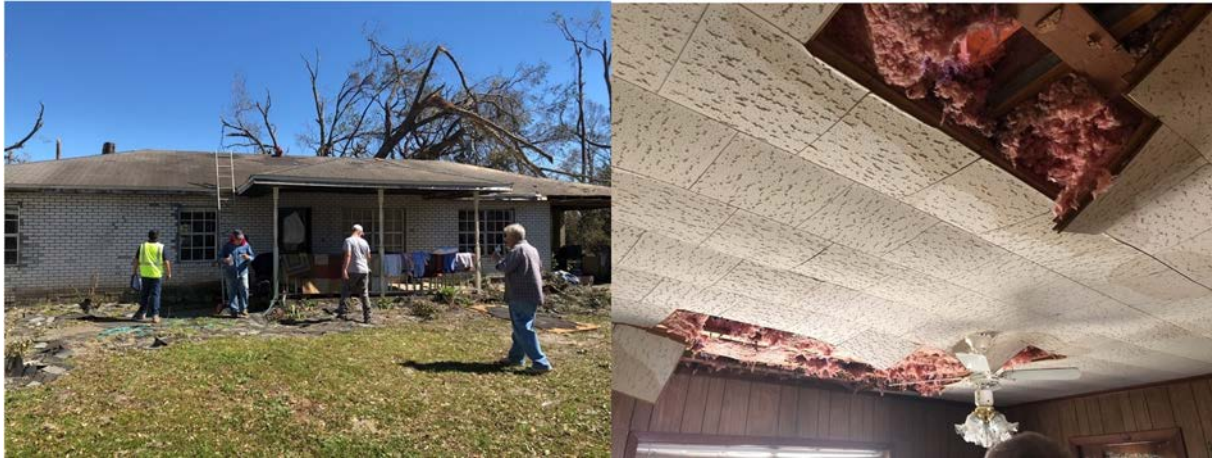
Figure 11: Example of tree damage observed in Southport

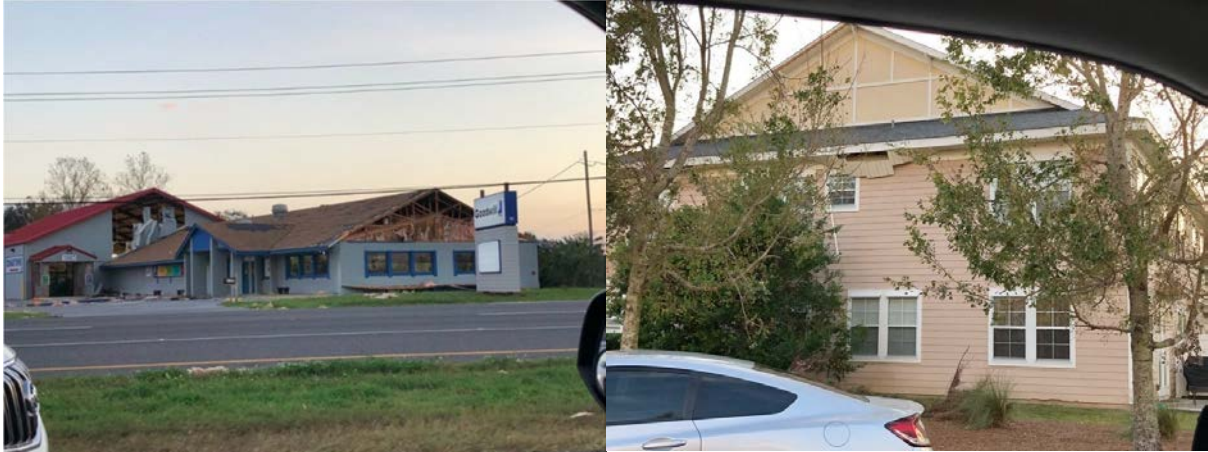
Figure 12: (left) Commercial building in Panama City Beach sustaining severe wind damage. (Right) Multifamily building under construction sustaining minor wind damage in Panama City Beach.

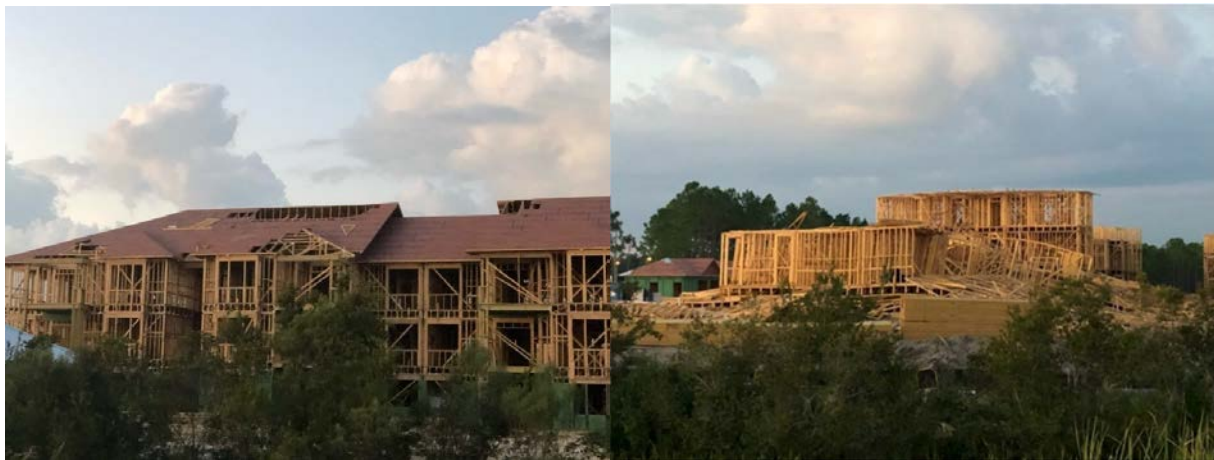
D2D assessments were conducted in Panama City Beach, Laguna, and Rosemary Beach by FAT-1 on October 14, 15, and 17 near US Highway 30 and US Highway 98. Assessments were mostly conducted between Front Beach Rd. and US Highway 98. The assessed sites are concentrated from E. Lakeshore Dr. in Laguna Beach to St. Thomas Dr. in Panama City Beach. Three commercial buildings, 2 hotels, 2 residential buildings, and 3 buildings specified as 'other' were surveyed in the D2D assessment; those sustaining damage had preliminary overall wind damage ratings of minor (N=5), moderate (N=4), and severe (N=2). Preliminary analysis of D2D data indicates damage predominantly driven by wind, which include moderate to substantial roof and wall damage. These can be described by loss of sheathing, soffit damage, gutter damage, and shingle/tile loss (Fig. 12). Damage was also observed to wood-framed buildings that were under construction at the time of the storm (Fig. 13).

Figure 13: Construction sites in Panama City Beach sustaining moderate wind damage.

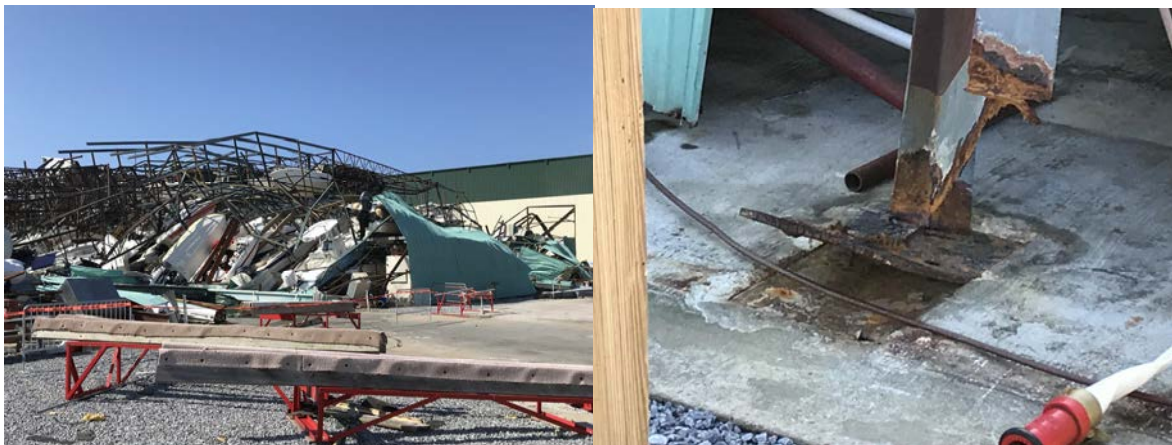
Collapse of three metal buildings associated with marinas were assessed in Panama City Beach (Figs. 14-15). While there is no doubt of the intensity of the wind speeds in Panama City Beach, forensic investigation revealed many connections of steel framing to their footings that were corroded to be point of significant loss of section and strength. In particular these conditions are likely to occur where the structures are located along the water and exposed to the environmental conditions salt air in marine locations.

Figure 14: Collapse of a storage building (left) with corrosion and material loss in columns and baseplates (right).

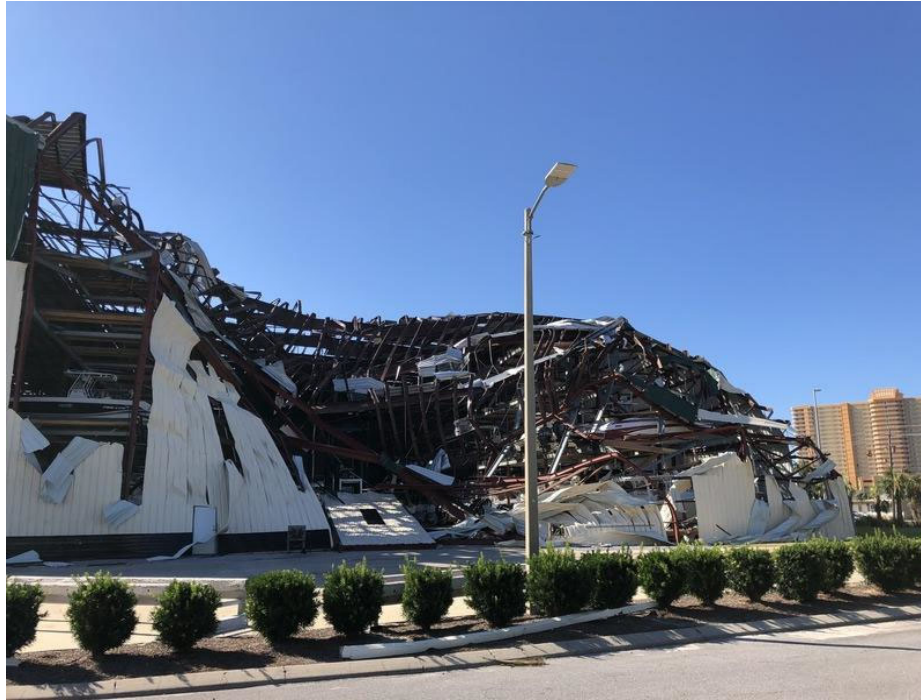
Figure 15: Partial collapse of a metal building marina in Panama City Beach.

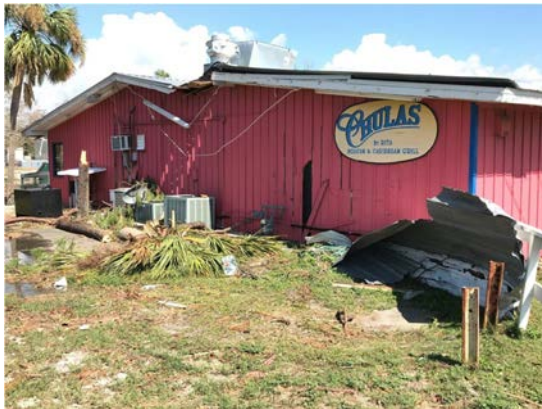
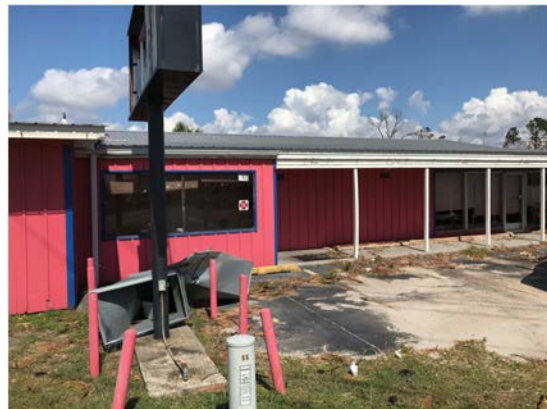
Figure 16: Commercial structure in Interior Panama City Sustaining minor wind damage.

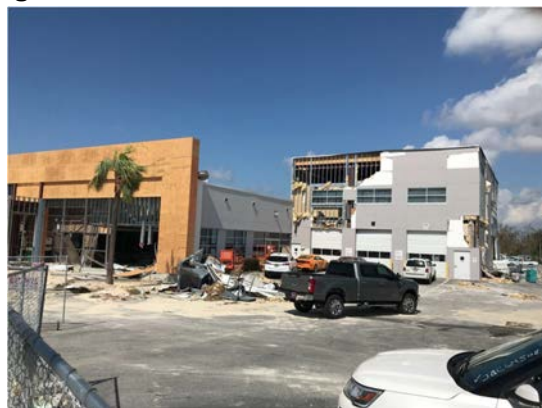
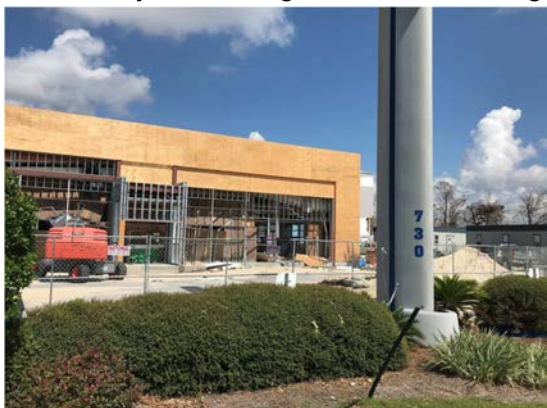
Figure 17: Commercial structure in Interior Panama City Sustaining moderate wind damage.

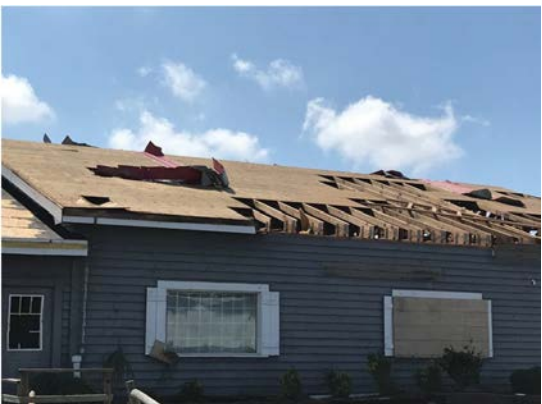
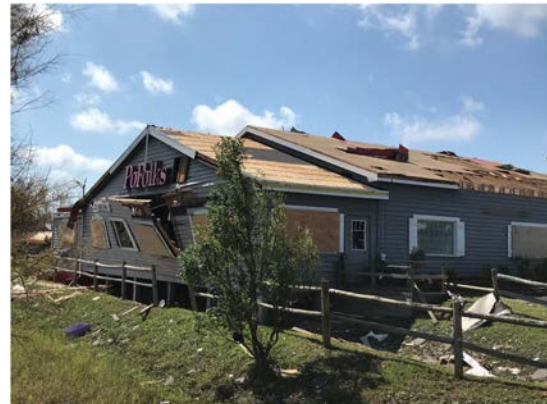
Figure 18: Commercial structure in Interior Panama City Sustaining severe wind damage.

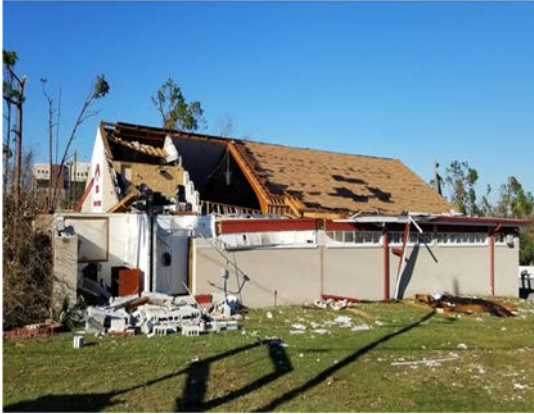
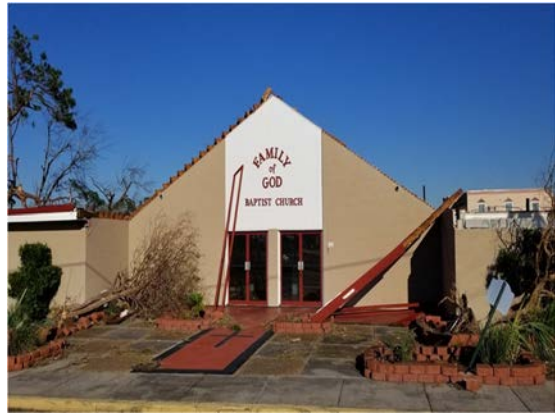
Figure 19: Severely damaged roof at Family of God Baptist Church at 901 US-98 BUS, Panama City (Captured by: Tim Johnson)

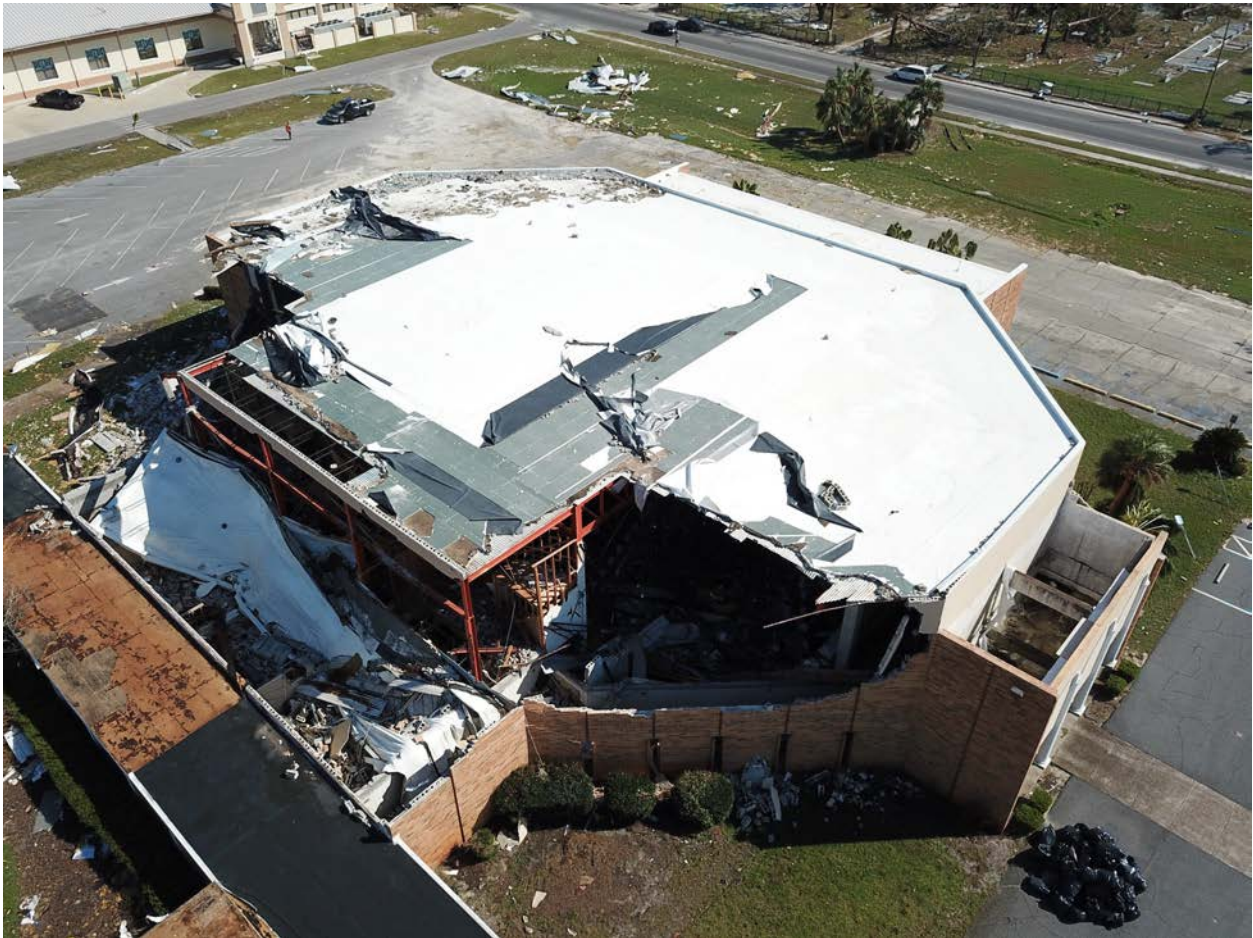
Figure 20: Failure of roof cover and exterior wall of a gymnasium at the Bay County Prep Academy (Lat: 30.16902, Long: -85.67445).

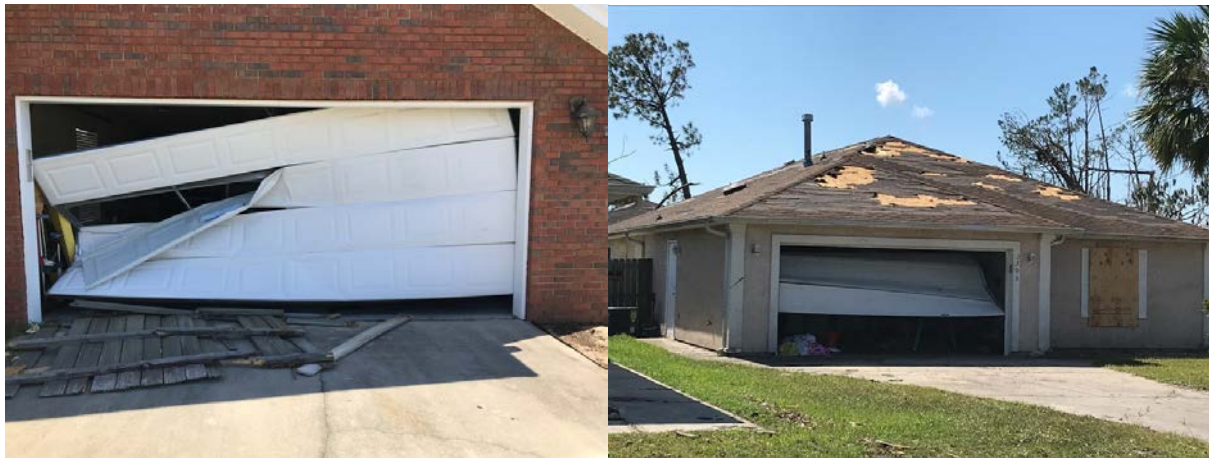
Figure 21: Garage door failures in residential homes in Cedar's Crossing.

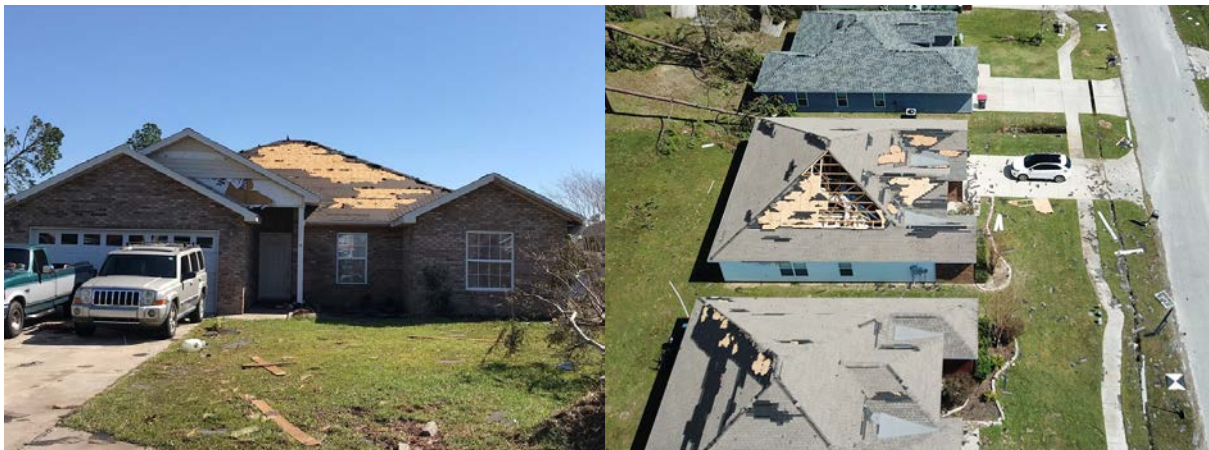
Figure 22: Damage to roof cover and roof sheathing in residential homes in Cedar's Crossing.

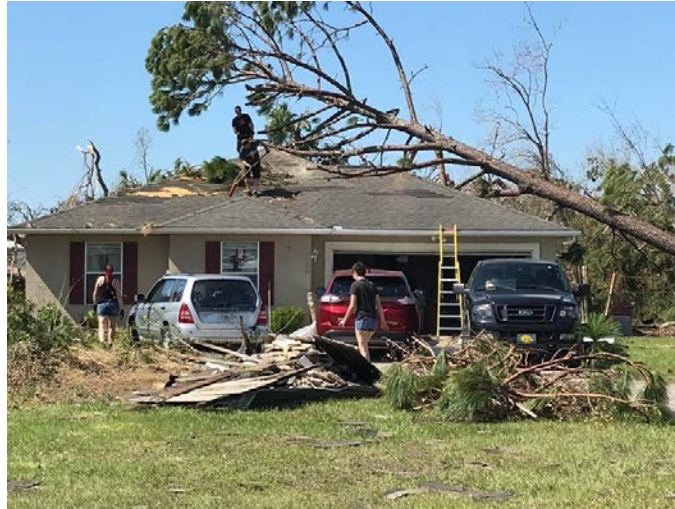
Figure 23: Example of tree damage in Cedar's Crossing.

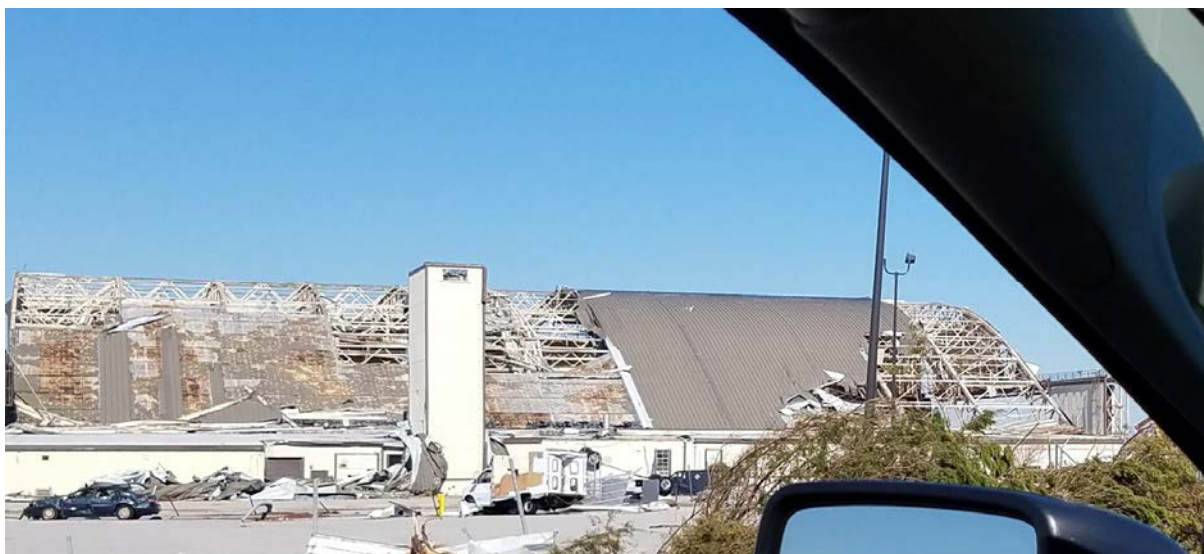
StEER did not attempt to access Tyndall Air Force Base, but significant damage to a number of buildings was observed from US-98, including several large aircraft hangars (Fig. 24), on-base housing, and experimental laboratories.

Figure 24: Severe wind damage observed to a large aircraft hangar on the Tyndall Air Force base, with almost complete failure of the corrugated metal roof cladding system.

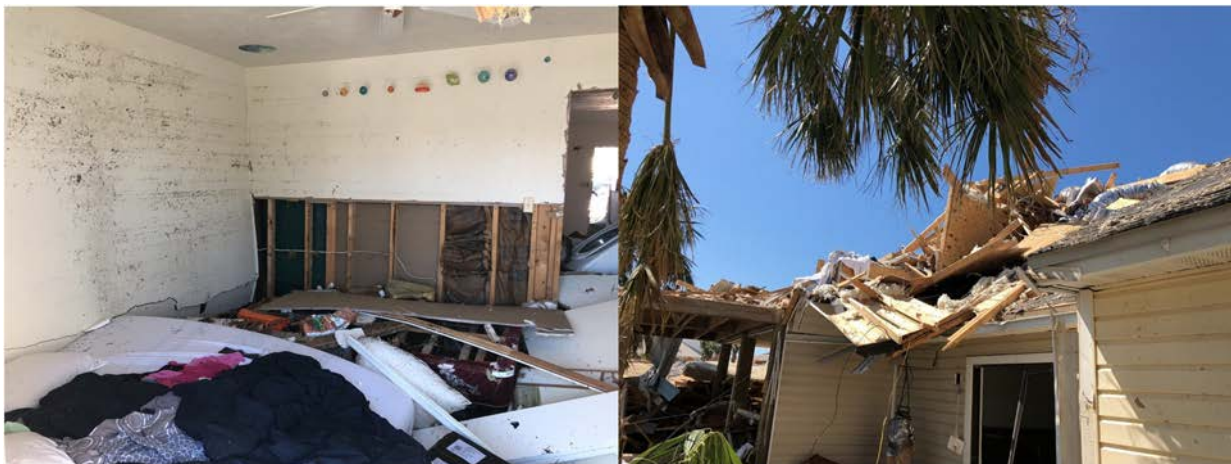
Figure 25: Example of storm surge damage in Mexico Beach. High water mark, 8" short of the 8 ft ceiling, slab is elevated 5" above ground level so surge height estimated 93" AGL.

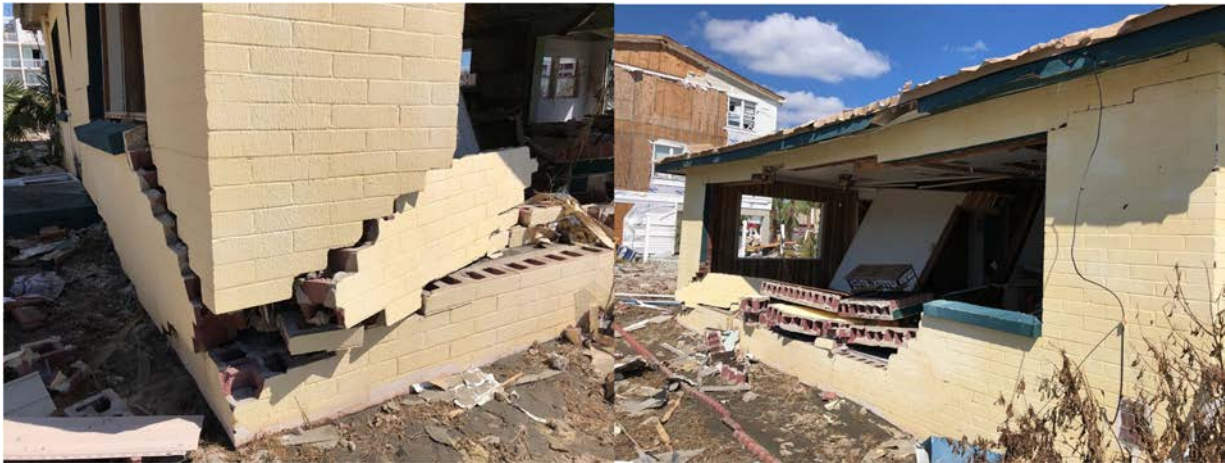
Figure 26: Severe damage to a masonry building observed in Mexico Beach (likely due to storm surge).

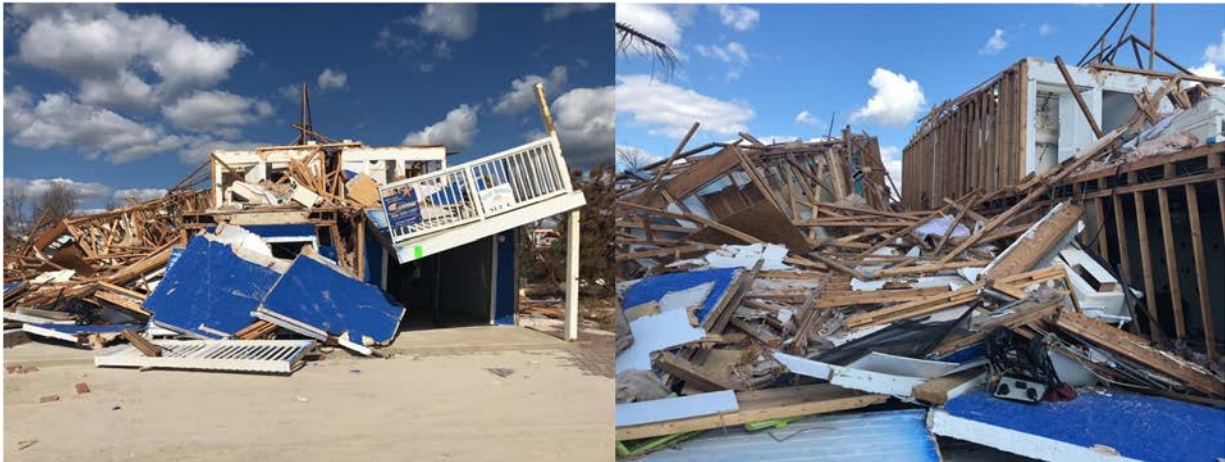
Figure 27: Example of total destruction of residential construction in Mexico Beach.

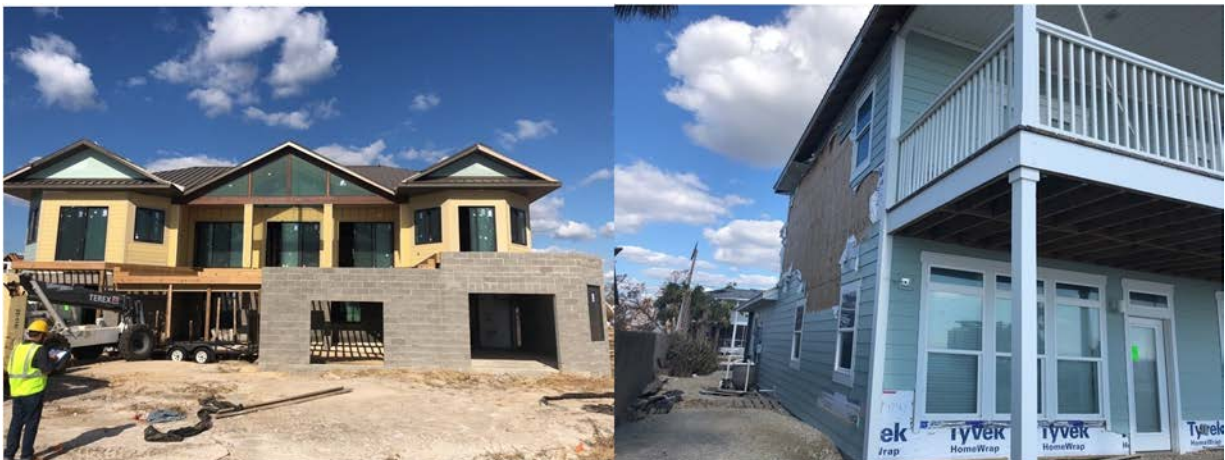
Figure 28: Newer buildings with minor damage in Mexico Beach.

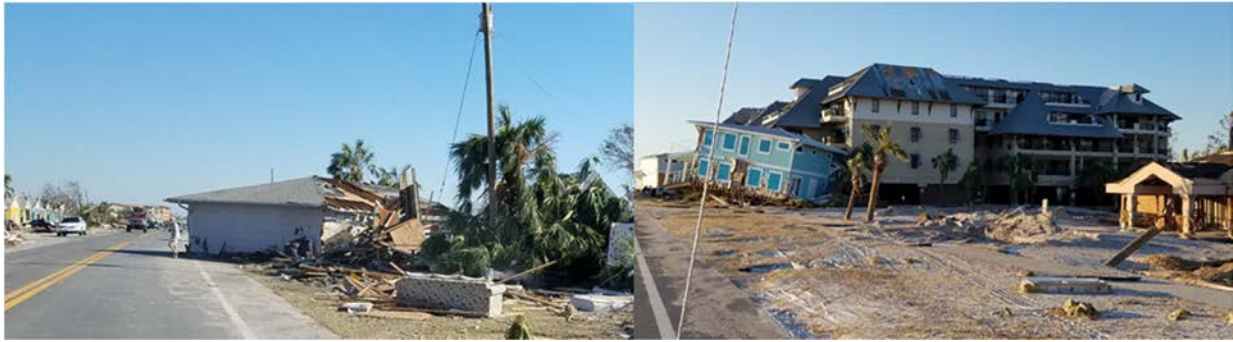
Figure 29: (left) Home pushed on to US-98 by storm surge; (right) Home pushed into multi-family residential complex by storm surge in Mexico Beach.

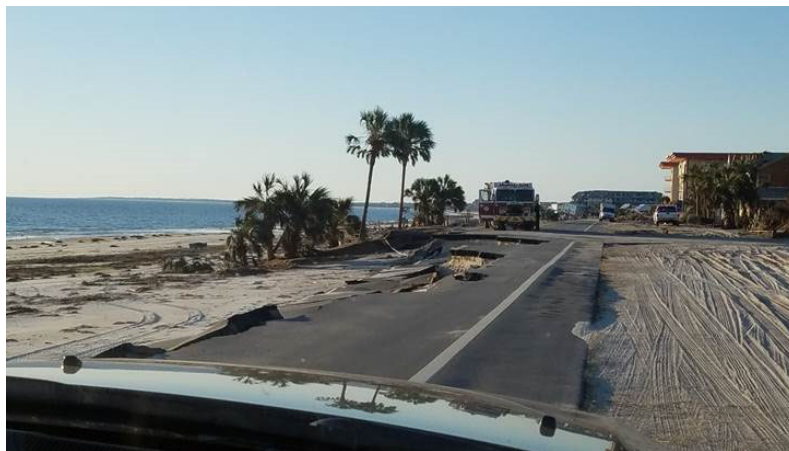
Site Conditions: Portions of US-98 are washed out (Fig. 30), limiting travel. Debris cleanup is still ongoing. Duke Energy supplies power to Mexico Beach and began restoration on October 22, but no timeline for power restoration has been made available yet.

Figure 30: Road washout near US Hwy 98 in Mexico Beach (Latitude: 29.935440, Longitude: -85.400476).

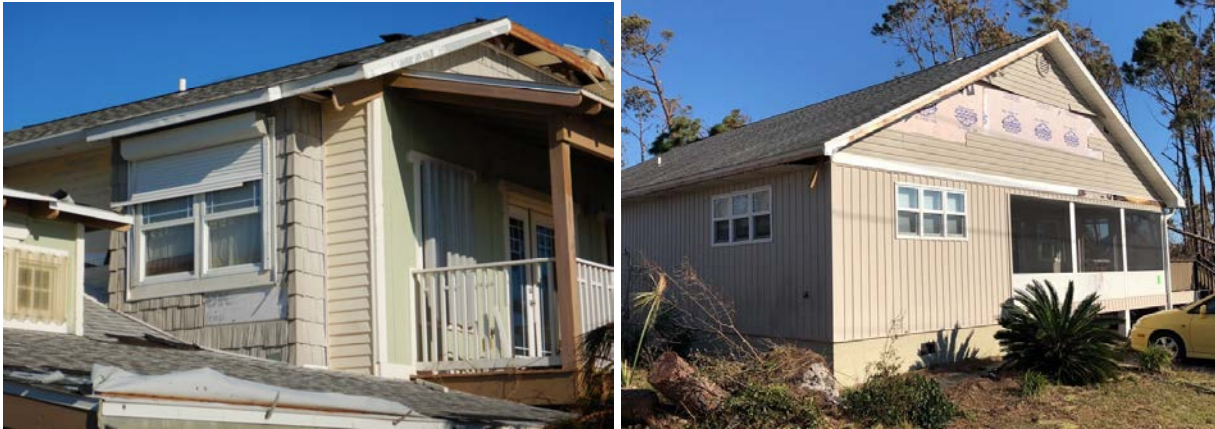
Figure 31: Examples of minor damage to homes assessed near the intersection of Highways 98 and 386 in Mexico Beach.

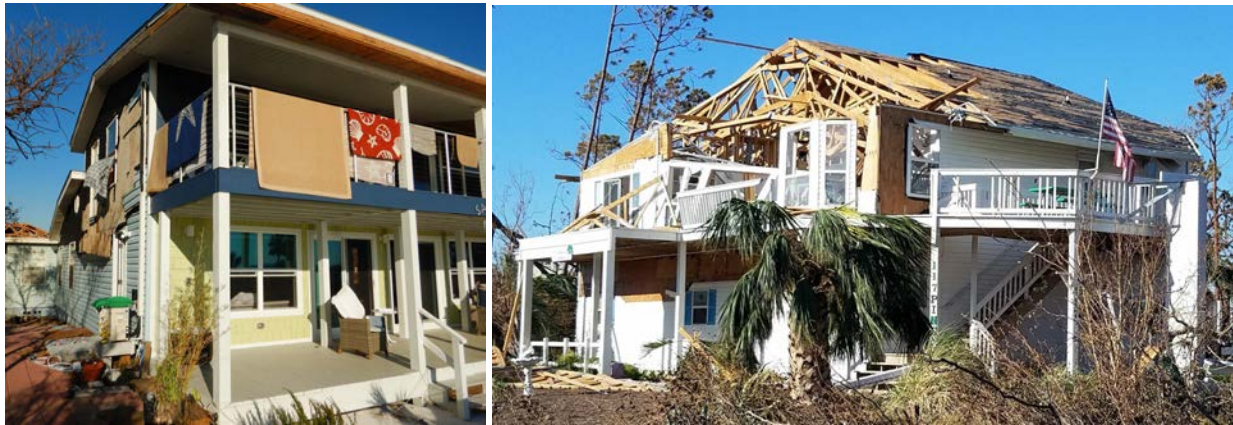
Figure 32: Examples of moderate (left) and severe (right) damage to homes assessed near the intersection of Highways 98 and 386 in Mexico Beach.

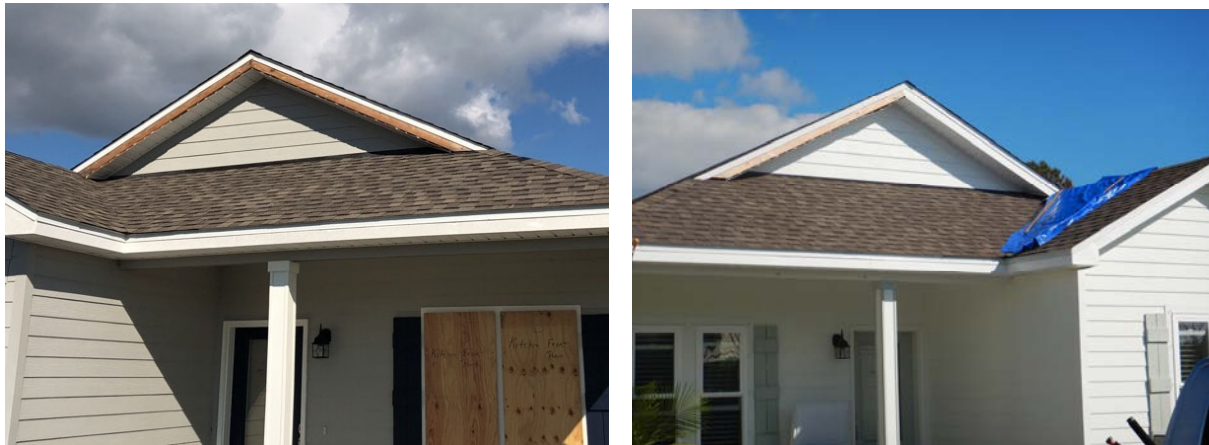
Based on discussions with the residents who were available, the homes have been built within the last five years, with some of the houses less than two years old. The primary forms of damage to these houses were loss of fascia boards and soffit damage, both under the eaves and under the entryways. There were also cases of minor shingle loss. Figure 33 shows examples of the

Figure 33: Typical fascia damage of homes in the Beacon by the Sea Community.

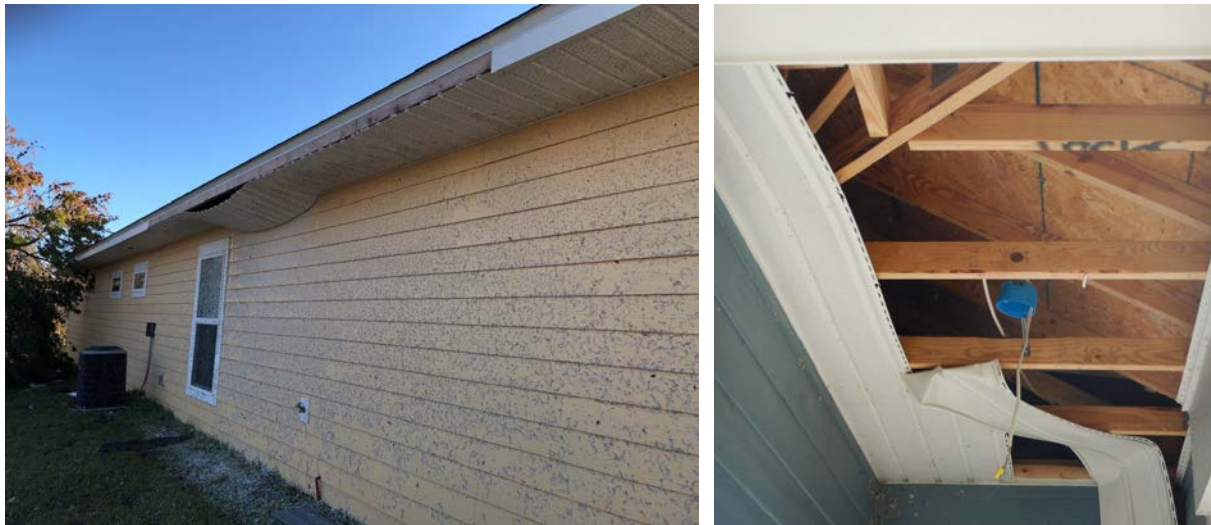
fascia loss and shingle loss. Figure 34 shows typical examples of soffit damage observed in the neighborhood. In discussions with several of the homeowners present, even when significant soffit damage and complete loss of attic insulation were documented (Fig. 34), significant water intrusion did not occur. While it was less common, there was siding damage to a few of the homes in the community, including vinyl, cement fiber and wood shake cladding systems. By far the most significant siding damage was seen in the assisted living facility adjacent to the community. Examples of siding loss are shown in Figure 35.

Figure 34: Typical soffit damage to homes in the Beacon by the Sea community.

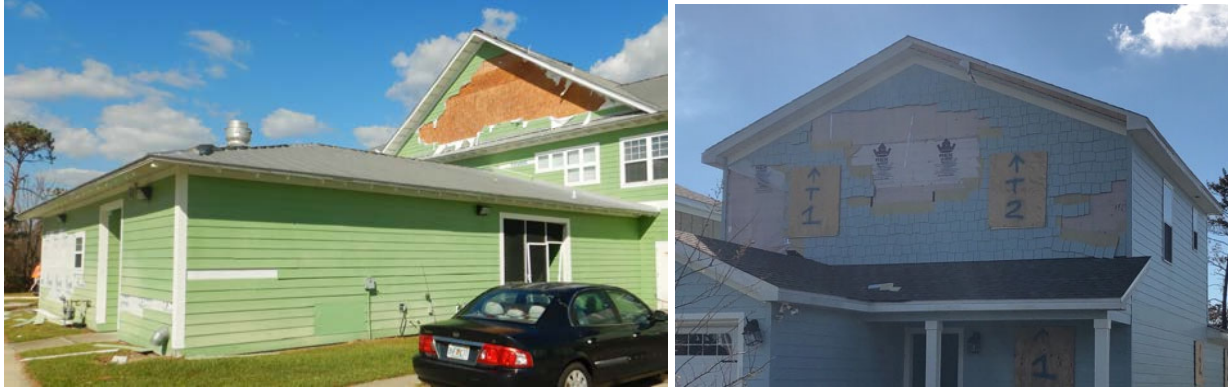
Figure 35: Examples of siding loss in an assisted living facility (left) and single family residence (right) in the Beacon by the Sea community.

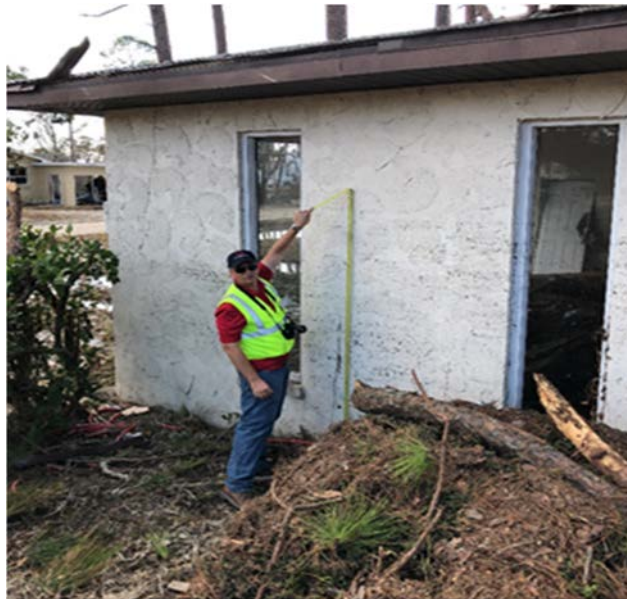
Surge high water mark of 72" was measured at Port St. Joe as shown in Figure 36. Wind damage was also severe in Port St. Joe, generally trending toward moderate and minor moving farther South. In general, it was seen that the surge footprint extended much farther south than the high-wind footprint. A surge-induced bridge failure (Fig. 37) was observed on 30A just South of Country Club road. New homes (less than 5 years old) along Four J's Rd. and Kaelyn Ln., less than a mile northeast of FCMP T2, performed very well. All were single-story, most with gable roofs, and with a mix of wall cladding and roof cover materials. Most had engineered wood panels installed to protect glazed openings. Isolated roof cover and wall cladding damage was observed. Vinyl siding failed more frequently, typically in small lengths. Fascia damage was common. Conversations with multiple homeowners revealed no significant water ingress through the building envelope, even to homes with soffit damage (Fig. 38).

Figure 36: Surge high water mark (72") in Port St. Joe.

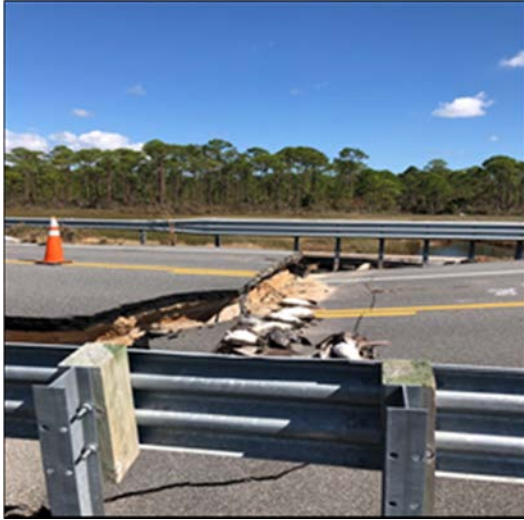
Figure 37: Surge-induced bridge failure on 30A South of Port St. Joe: (a) buckled road surface; (b) scour at abutment support.

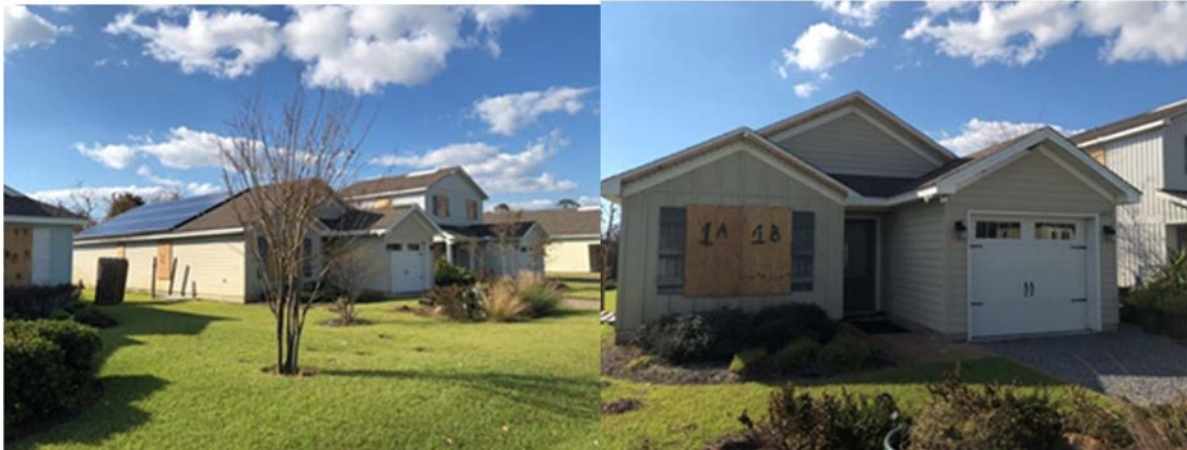
Figure 38: Residential structure in Port. St. Joe with solar panels intact (left) and minor vinyl soffit damage to front elevation (right), windows were covered with plywood.

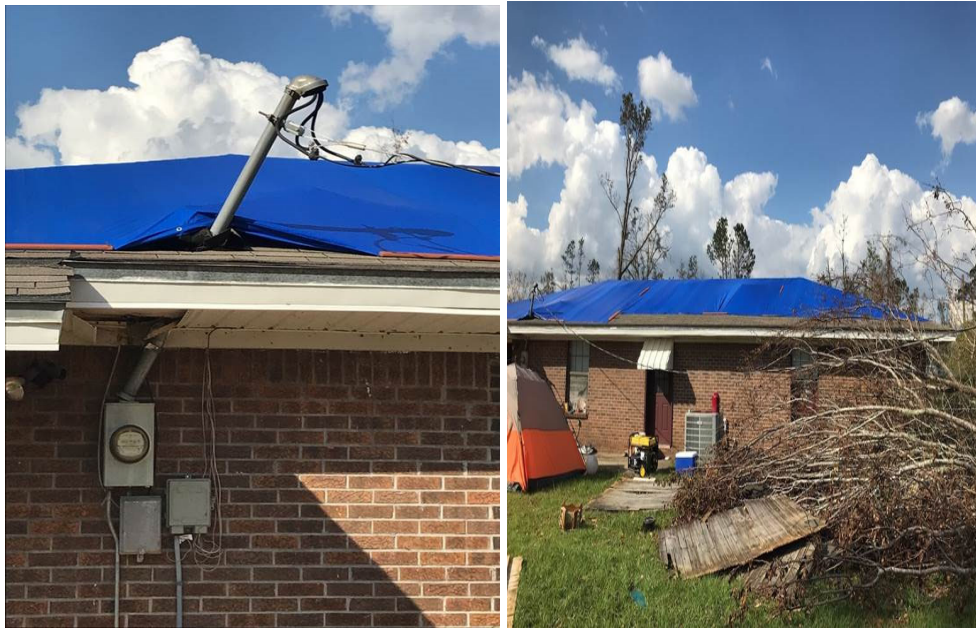
Figure 39: Damaged electricity conductor present in a building near Lambert Ave. in Blountstown.

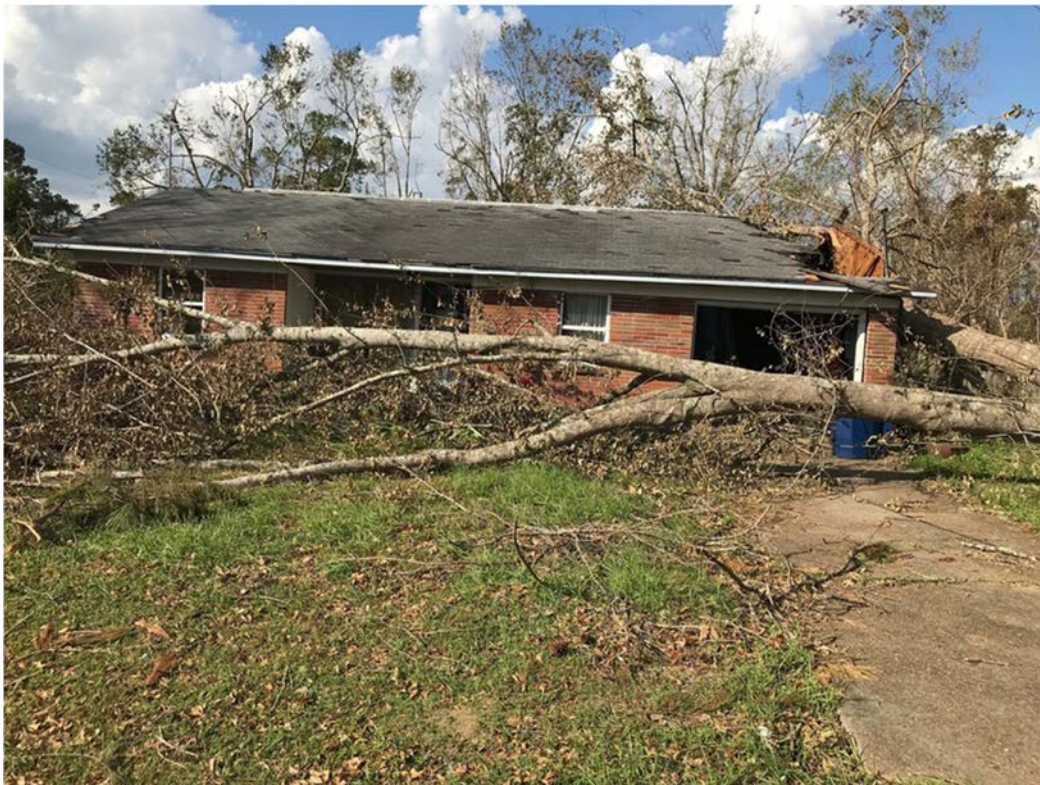
Figure 40: Residential building sustaining severe damage due to tree fall at NE Lambert St. in Blountstown.

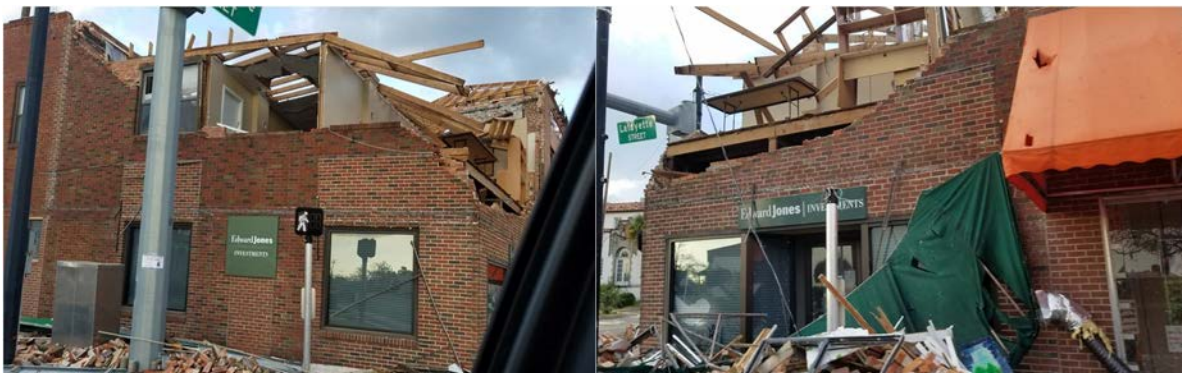
Figure 41: Commercial building (Edward Jones investments) with wall collapsed and roof structure damaged on Lafayette St. in Marianna.

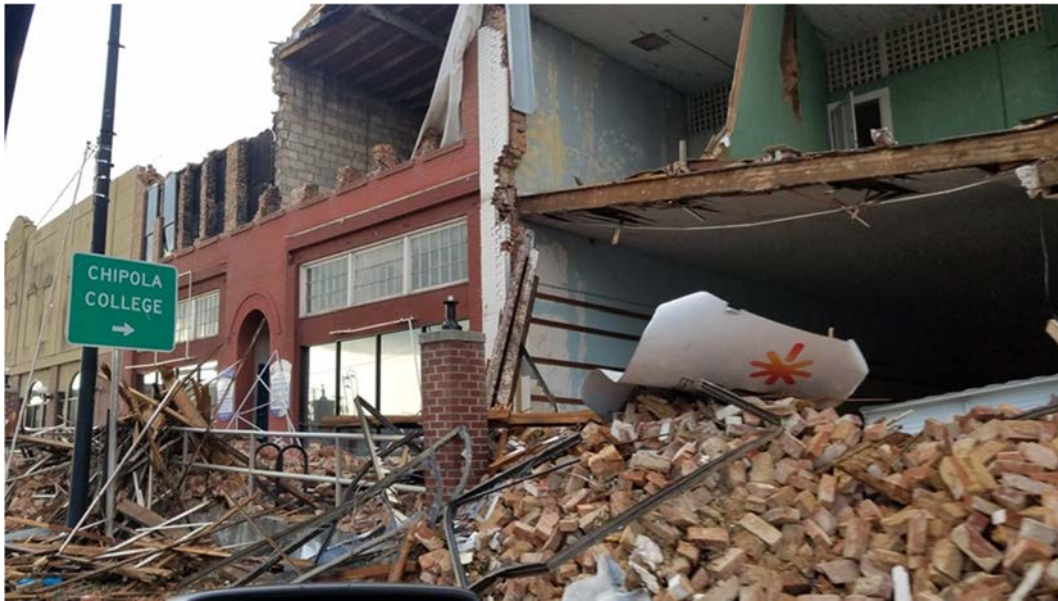
Figure 42: Commercial buildings with masonry walls collapsed and roof structure damage on Lafayette St. in Marianna.

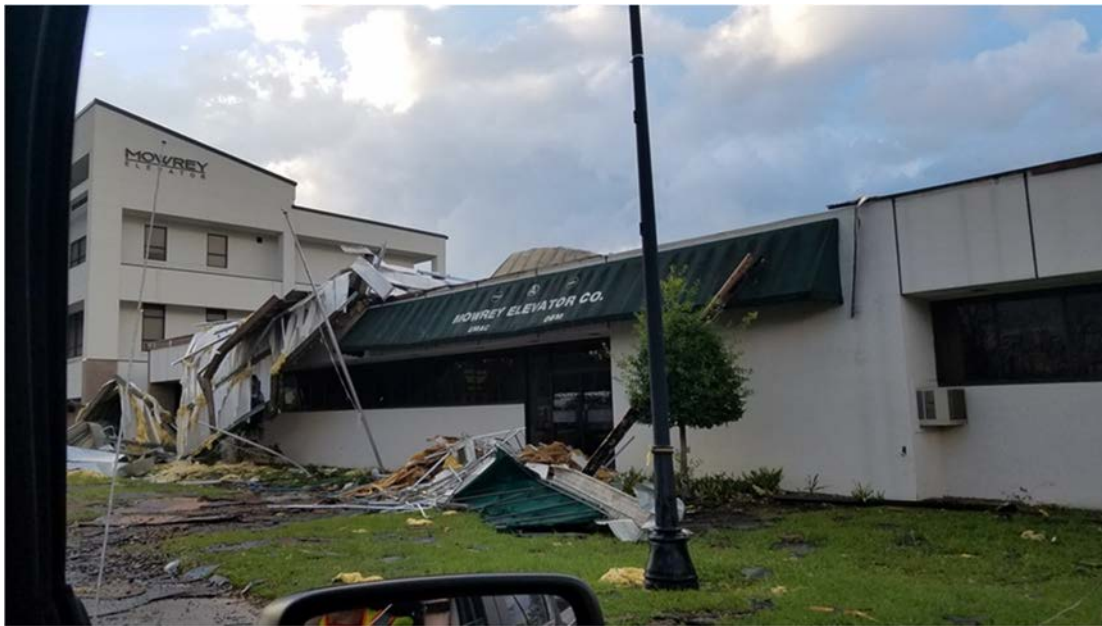
Figure 43. Commercial building (Mowery Elevators) sustaining severe roof damage on Lafayette St. in Marianna.

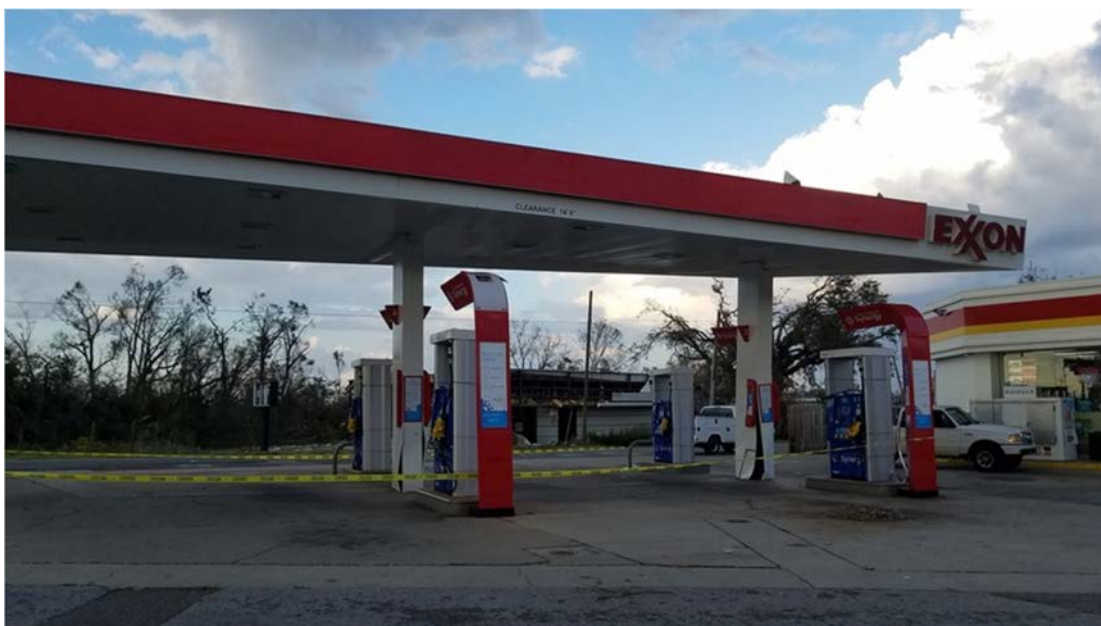
Figure 44: Exxon station sustaining column and roof damage at US 90 in Marianna.

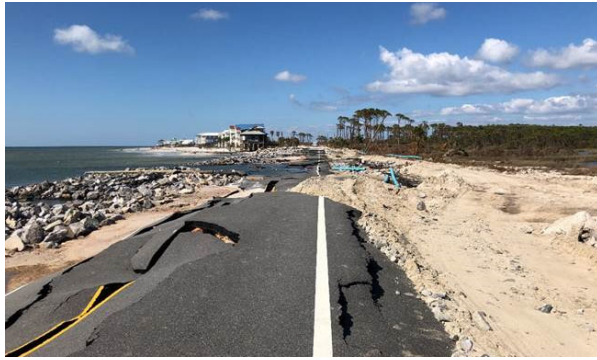
Figure 45: Road washout on Highway 30E (Cape San Blas Rd) on Saint Joseph Barrier Island (Latitude: 29.680619, Longitude: -85.366115).

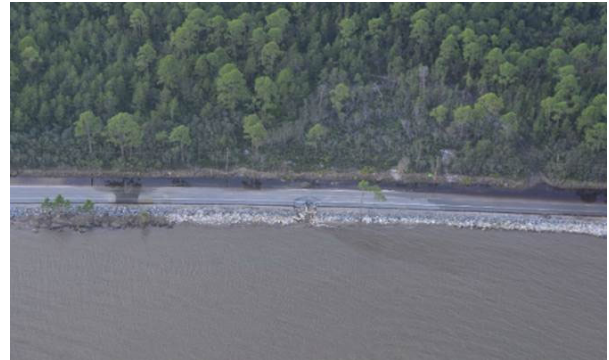
Figure 46: Road wash out US Hwy 98 (Big Bend Scenic Byway Coastal Trail) (Latitude: 29.772736, Longitude: -84.793465) (Source: [ESRI StoryMap](#)).

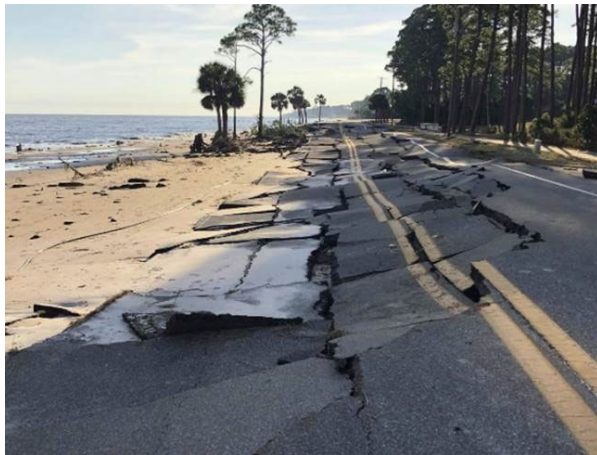
Figure 47: Road washout US Hwy 98 near Carrabelle (Latitude: 29.827057, Longitude: -84.696981) (Source: [ESRI StoryMap](#)).

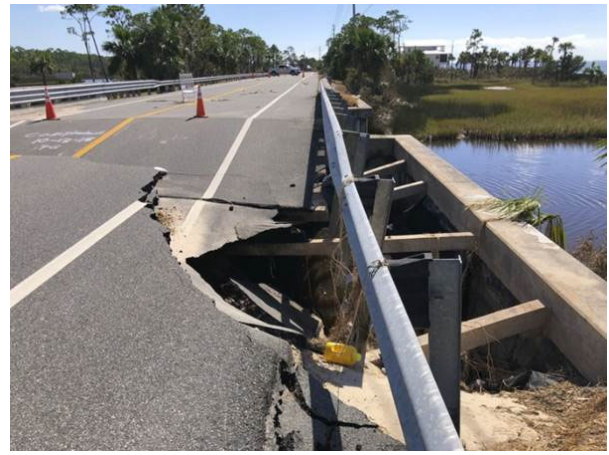
A majority of closures that were reported in the P-VAT report have been lifted as they constituted cautionary closures due to high winds or water or debris over the roadways/bridges. The remaining closures or loss of access are mostly due to sustained damage. The damage could be categorized as follows: damage to roadways due to raised water levels that resulted in washing out the subgrade (Figs. 45-47) or those due to high levels of storm surge (and potentially waves in some locations) that resulted in failure of bridges spans, approaches, and abutments (Fig. 48).

Figure 48: Bridge approach washout on Highway 30A Bridge near Saint Joseph Bay (Latitude: 29.754006, Longitude: -85.303750).
