StEER: Structural Extreme Event Reconnaissance Network

HURRICANE MICHAEL: FIELD ASSESSMENT TEAM 1 (FAT-1) EARLY ACCESS RECONNAISSANCE REPORT (EARR)

Released: October 25, 2018
NHERI DesignSafe Project ID: PRJ-2111

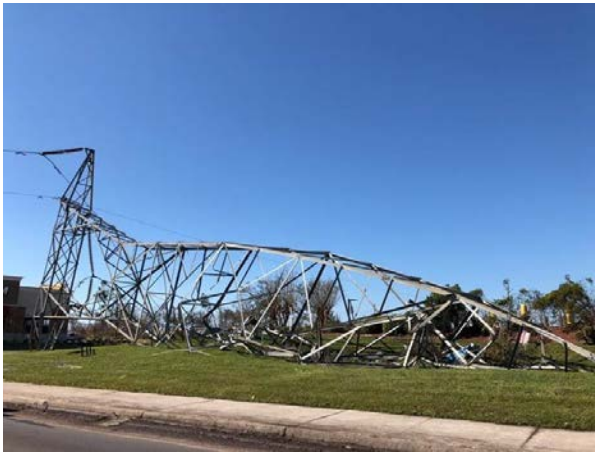
Most of the areas remain without the power, but utility crews are working to restore the power. The damage to the power infrastructure is observed at the level of transmission (high voltage) (Fig. 49), distribution poles (lower voltage), and also access points at individual housing locations. The damages observed seem to be a combination of the bending and shear failure at the base of the poles (Fig. 50), or snapping of the tip of the pole where the attachments are connected (Fig. 51). There are cases of one pole failure leading to a domino effect in multiple poles. Some of the failures may be as a result of not only the high winds but also the impact from flying debris from adjacent structures or fallen trees or branches of trees (Fig. 52). The damage to the transmission

Figure 49: Destroyed transmission tower near North Tyndall Parkway, Springfield (Latitude: 30.160519, Longitude: -85.591164).

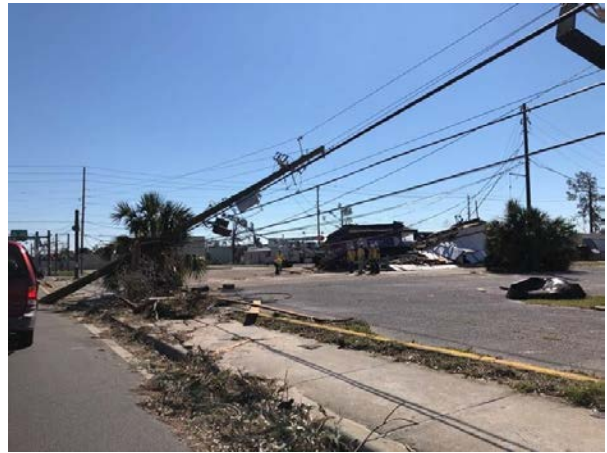
Figure 50: Damaged electric pole near West 15th St., Panama City (Latitude: 30.175136, Longitude: -85.663061).

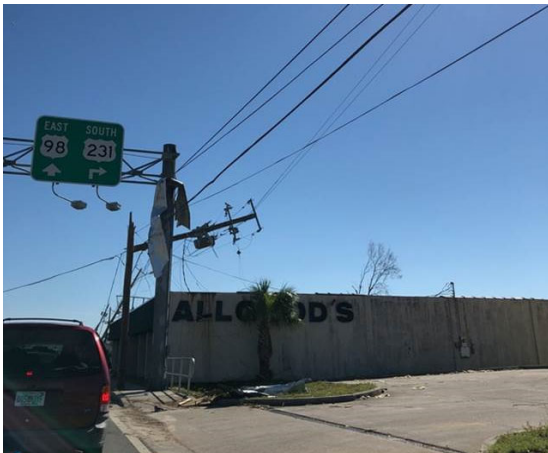
Figure 51: Damaged electric pole near West 15th St., Panama City (Latitude: 30.175136, Longitude: -85.663061).

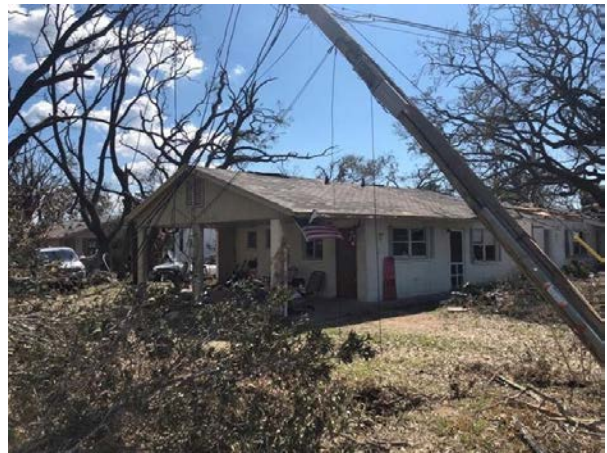
Figure 52: Damaged electric pole near Oakshore Dr., Parker (Latitude: 30.110311, Longitude: -85.60216) (Credit: Dean Ruark)
