Self-Sealing Asphalt Shingles – Technical Bulletin 3.0

Is My Roof Wind Damaged? Is Wind the Proximate Cause?

A Guide to the Various Stages of Wind Damage to Residential Asphalt Shingle Roofs and Repair Options for Each Stage

FORENSIC ENGINEERING & FIRE INVESTIGATION

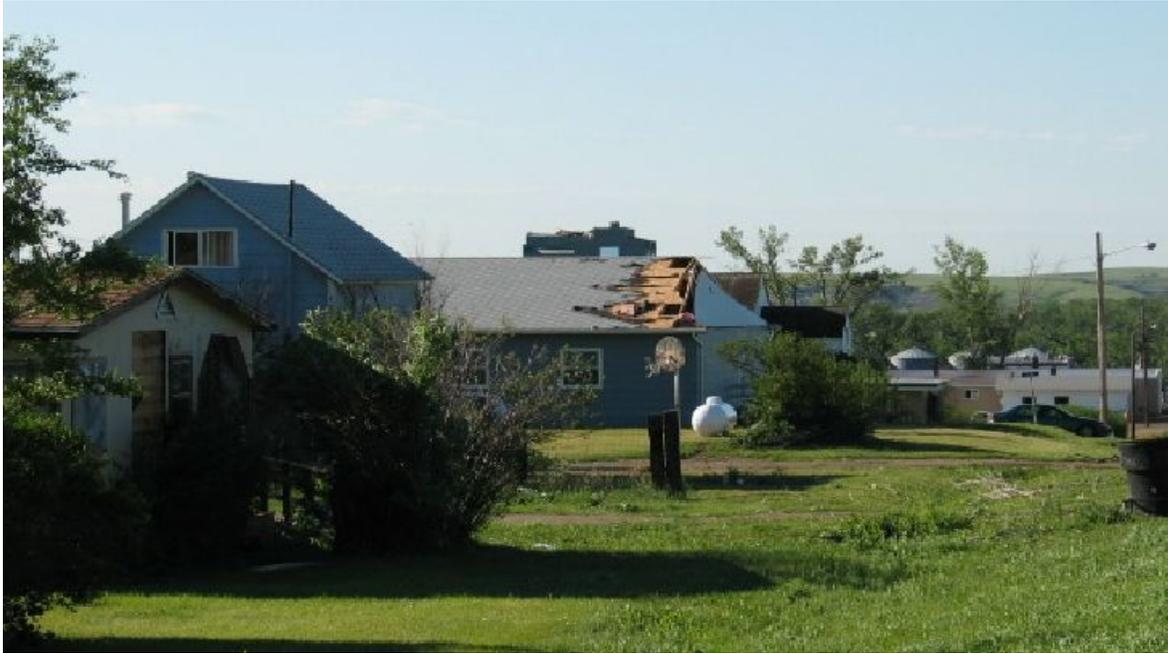
Photograph 1 – A gable roof that initially failed along the rake edge. Damage gradually progressed into the roof as the winds continued.

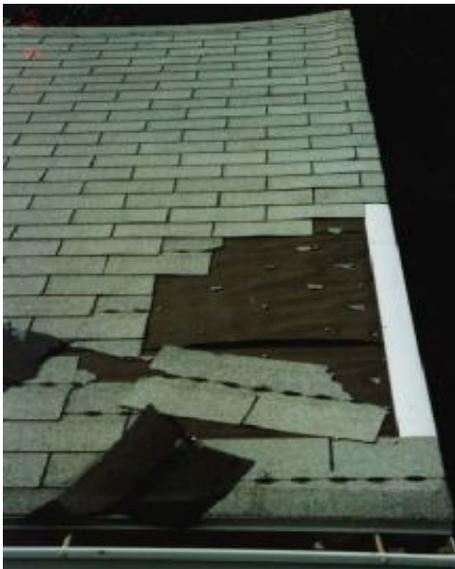
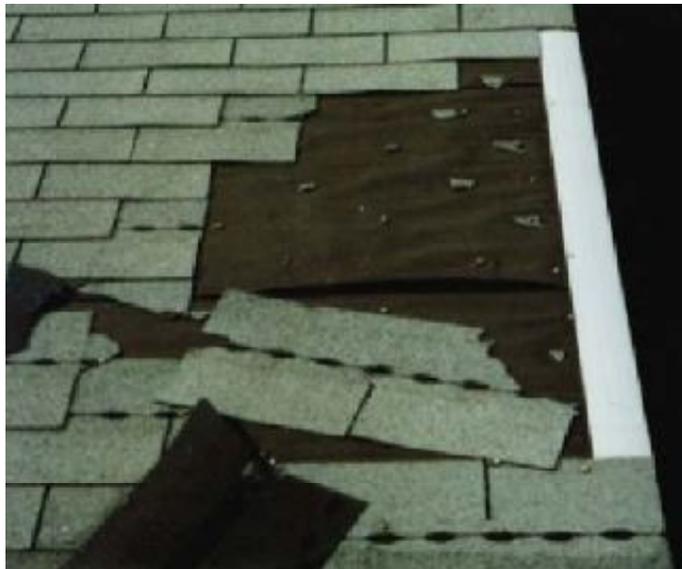
Photographs 2 & 3 – A gable roof that initially failed along the rake edge. Note in the close-up where wind ripped the shingles off, leaving bits of shingle behind around the nail heads. Such evidence is common with severe winds.

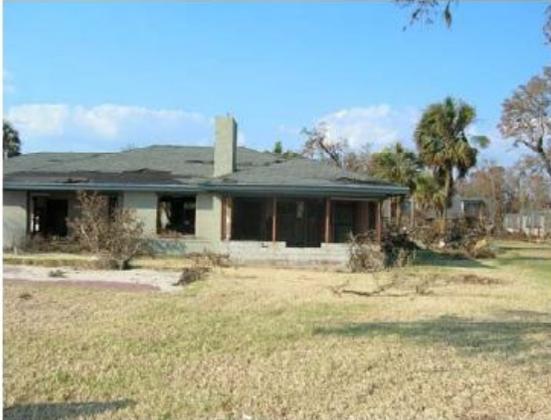
3.13-1. Residence. Ocean-front building with some shingles lost on windward side.

Photographs 4 & 5 – Wind damages initiating along the eaves of a house damaged from Hurricane Katrina (Roofing Industry Committee On Weather Issues - RICOWI).

As seen in the above examples, wind damages from winds that are “severe” generally initiate in the areas of known susceptibility based on wind direction and roof geometry. Specifically, roof corners, eaves, rakes, hips, and ridges are areas where failures may be expected to initiate. It is then clear why shingle fastening in these areas is so key to any roof’s ability to resist the damaging effects of wind.

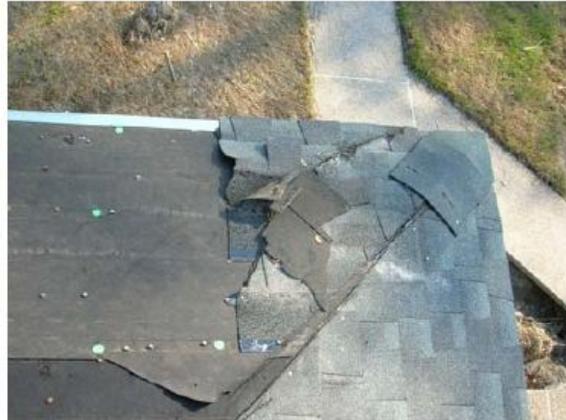
3.13-2. Residence. On this roof, shingles were torn loose from metal edge on the windward side.

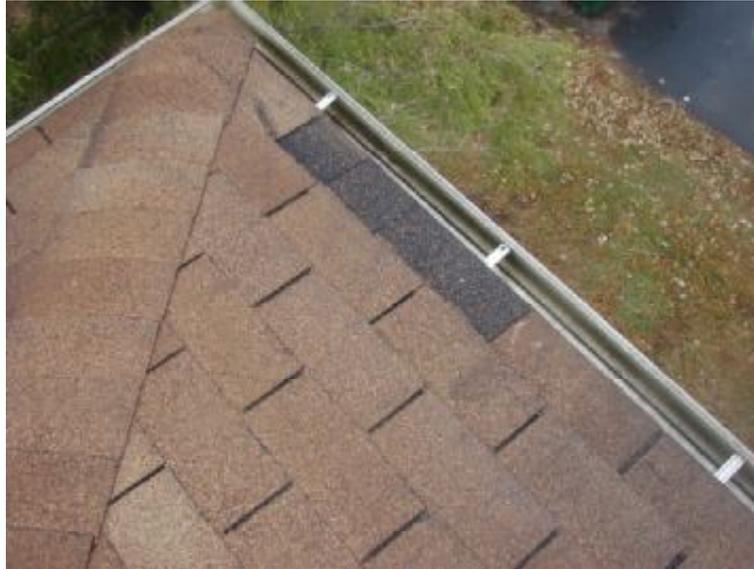
Photograph 6 – Wind damaged shingles along the first full course of this roof were blown off because the underlying starter course was not installed correctly. This is an example of the common mistake of simply installing a full three-tab shingle upside down as the starter course.

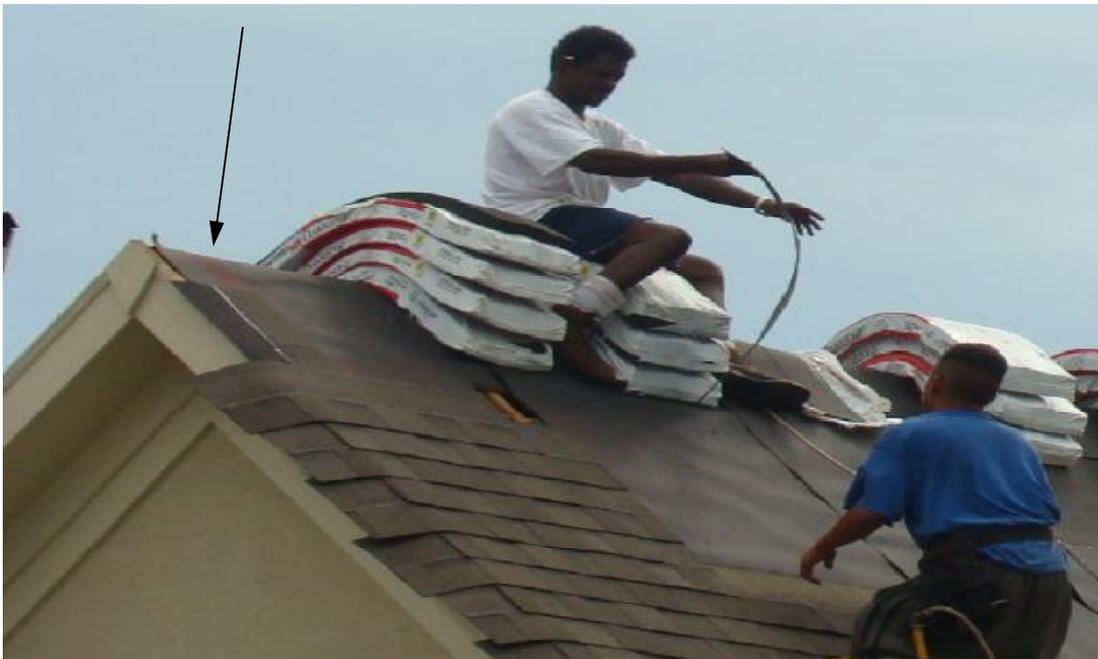
Photograph 7 – Improperly installed full-width three-tab shingle on its side along the rake edge of this roof. As a result, the shingles overlying this rake edge will never seal. Where is the drip edge? Why does the underlayment not extend to the edge?

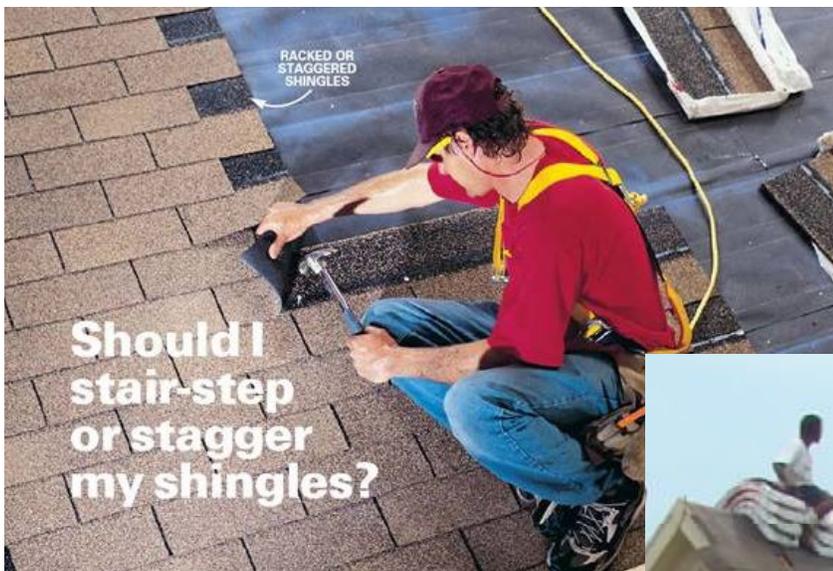
Photograph 8 above – An installer demonstrating proper vertical racking. Note how far he must uplift and bend back the previously-installed shingle to install the required end nail. For this reason, this nail is often omitted: a key installation mistake that leads to wind damage. (Source unknown)

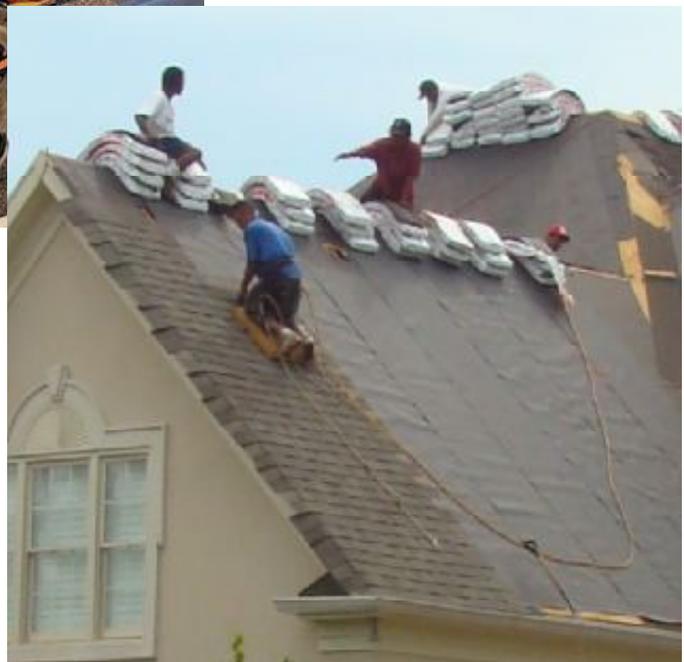
Photograph 9 above – A roofing crew taking numerous safety risks as they make many errors installing this roof using the vertical racking method.

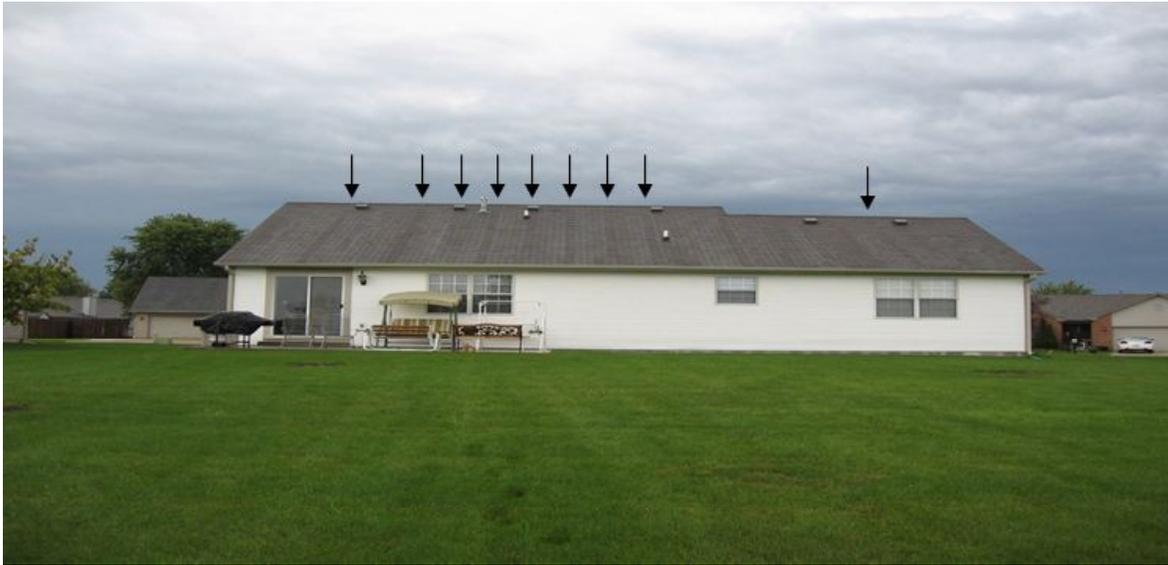
Photograph 10 – Contractors who install shingles via the vertical racking method commonly create roofs that contain visually unappealing lines as seen in this example. Moreover, these lines generally correspond to lines of unsealed shingles: shingles that are inherently prone to damage from otherwise undamaging winds.

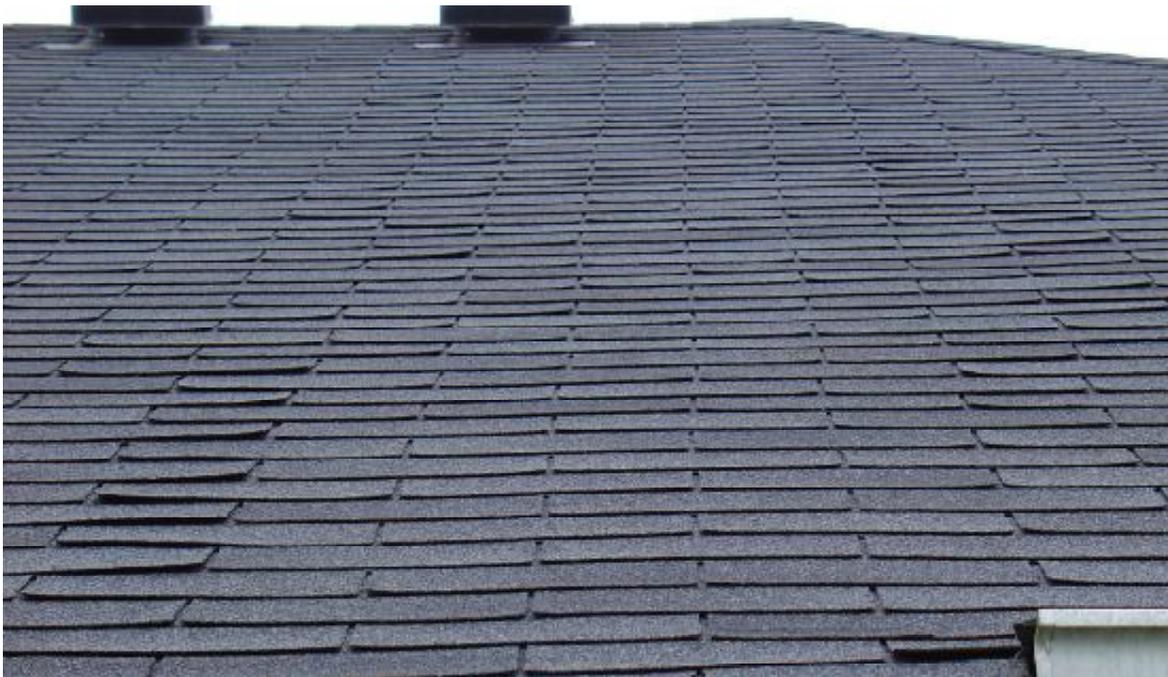
Photograph 11 – Loose shingles spaced exactly three-tabs apart are an easy indication of vertical racking installation damage and have nothing to do with wind. Often these shingles become more visible after a strong wind, but were previously loose and never sealed due to the poor practices of the installer.

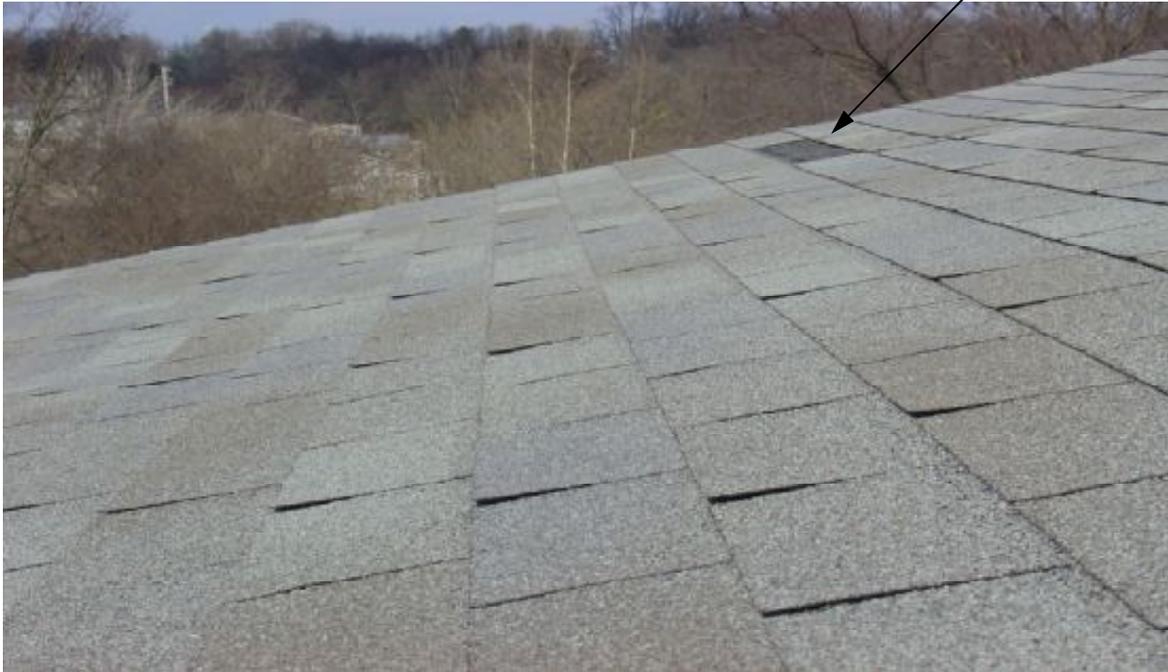
Photograph 12 – Loose shingle corners spaced exactly three shingle tabs apart are an unfortunate byproduct of an installer damaging the roof during vertical racking shingle installation. As a result, this roof is inherently prone to unnecessary wind damage as pointed out by the arrow.

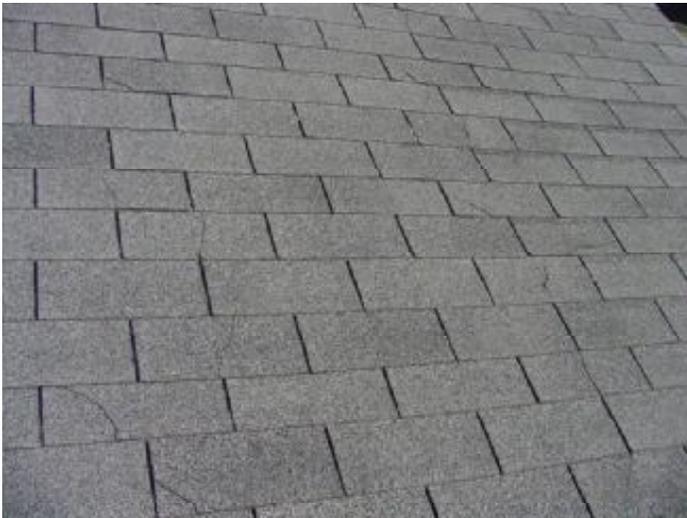
Photograph 13 left – This consistent pattern of vertical tears directly above keyways and diagonal tears across shingle corners is evidence of the installer damaging the roof as he installed it during the vertical racking method.

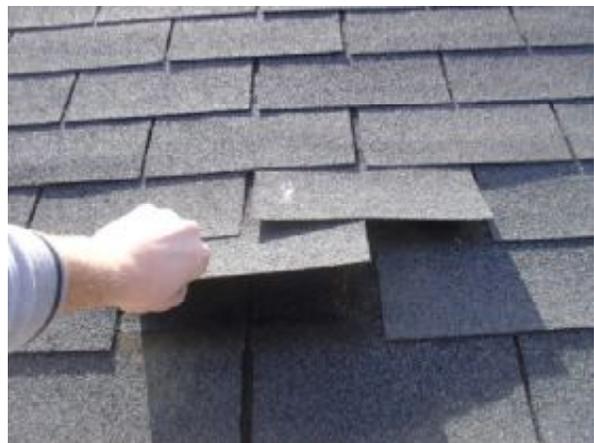
Photograph 14 right – Loose shingles that do not correspond to tears, creases, or broken seal strips and that occur in vertical lines on a roof are a clear indication of the vertical racking method of shingle installation and are not related to wind.

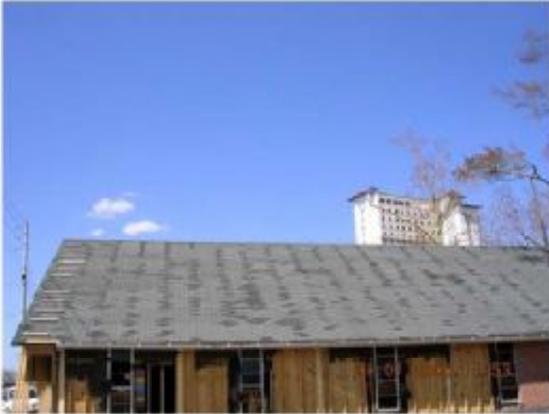
3.03-1. Living Waters Church. Torn tabs at unattached ends of shingles follow a vertical pattern.

Photographs 15 & 16 – An asphalt shingle roof on a church that was damaged in Hurricane Katrina. The damages clearly illustrate the vertical racking method of installation. Note the lack of damages to the roof's rake, ridge, corners, and eave that clearly indicates that it is the contractor's practice, not the wind, which is the proximate cause of loss. (RICOWI)

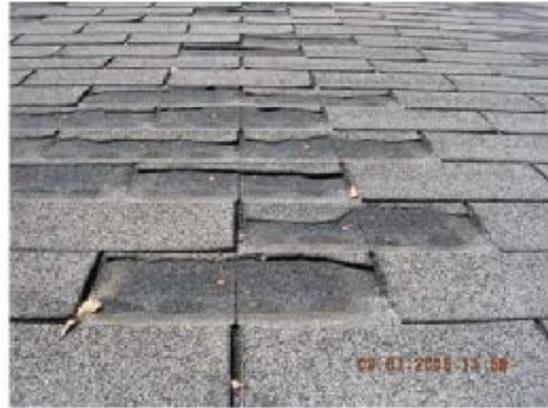
3.03-2. Living Waters Church. A closer view of torn shingles shows missing nails in alternating courses.

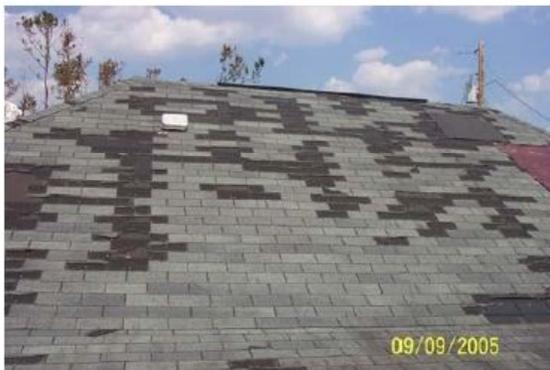
3.15-1. Residence. This roof was installed using a vertical "racking" installation method, which resulted in significant damage to many of the 3-tab shingles.

Photographs 17 & 18 – An asphalt shingle roof that was damaged in Hurricane Katrina. The damages clearly illustrate the vertical racking method of installation. (RICOWI)

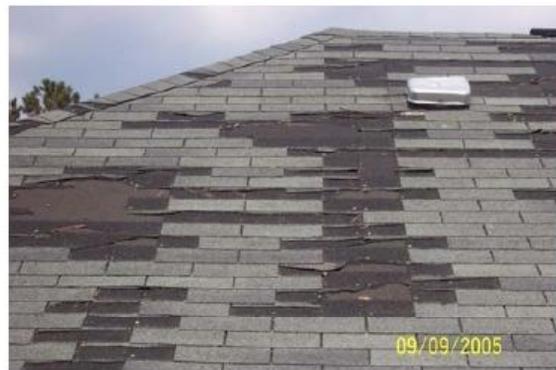
3.15-2. Residence. Fasteners were missing on alternating courses of shingles.

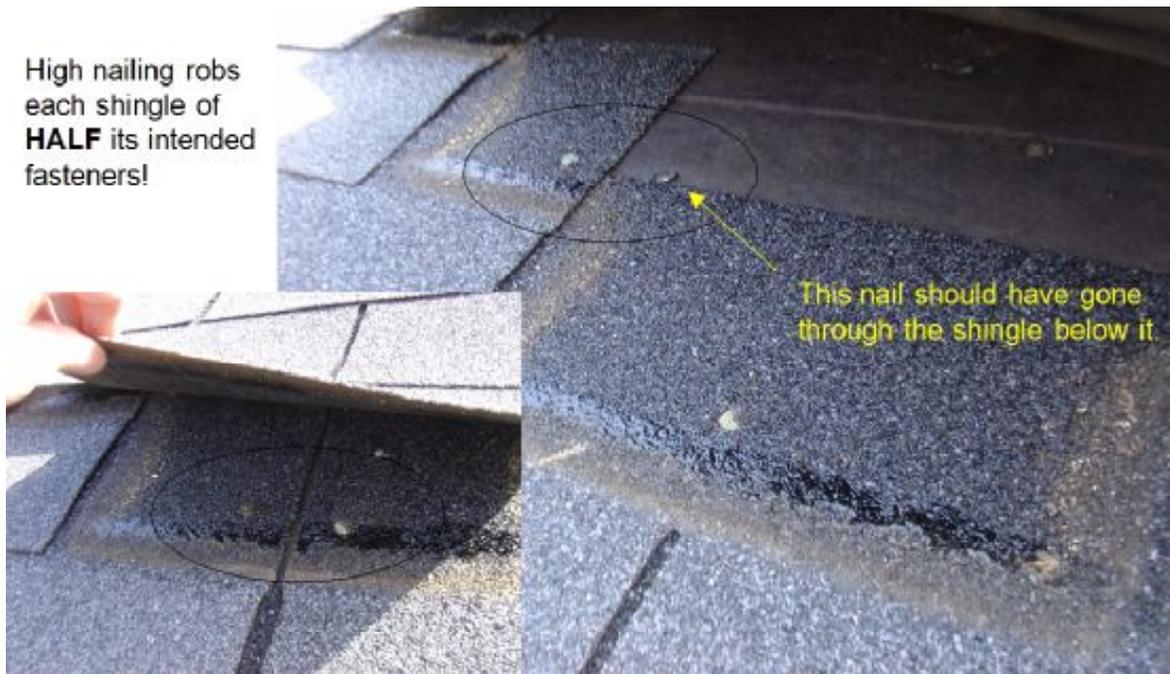
Photographs 19 & 20 – High nailing shingles prevents the seal strips from coming into contact with the overlying shingle tab, thereby keeping it from sealing, and often robs the underlying shingle of nails that were supposed to help fasten the underlying shingle to the roof.

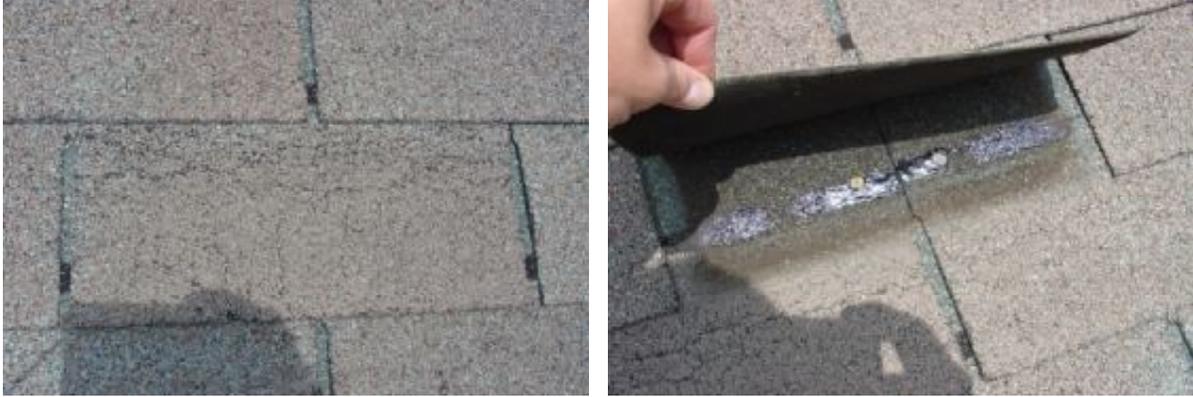
Photographs 21 & 22 – A wind-damaged shingle tab (as indicated by the crease going through the shingle mat) that was allowed to be damaged by wind by the installer, who high nailed the underlying shingle.

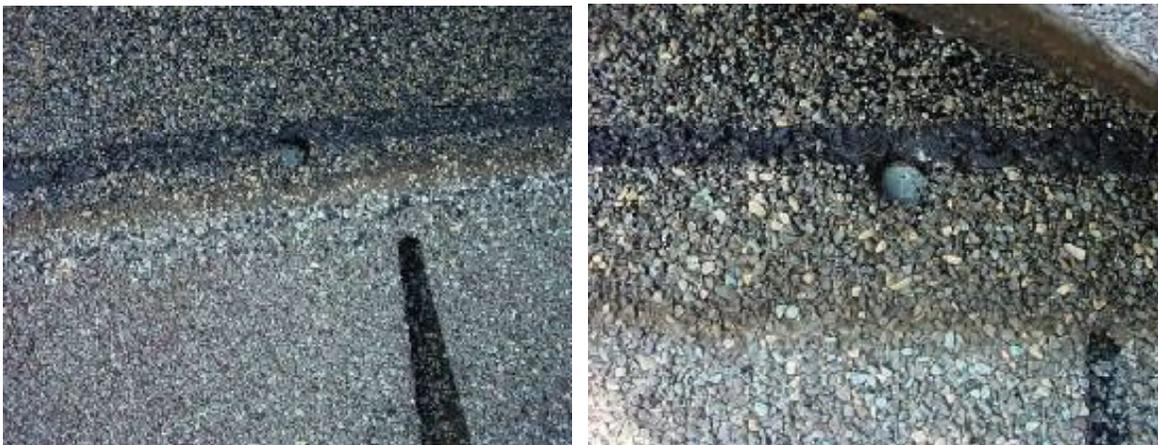
Photographs 23 & 24 – Over-driven nails that provide no benefit to the roof and make it prone to wind damage.

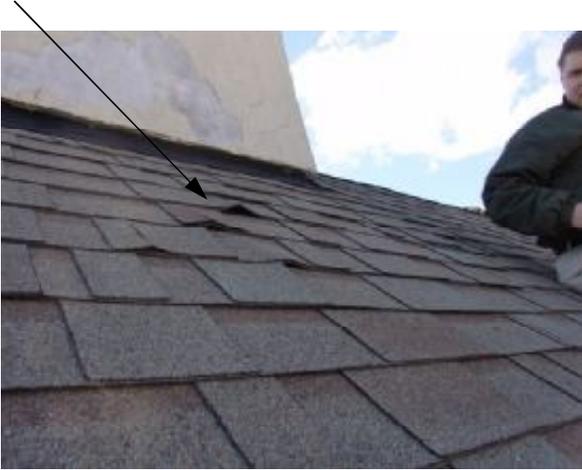
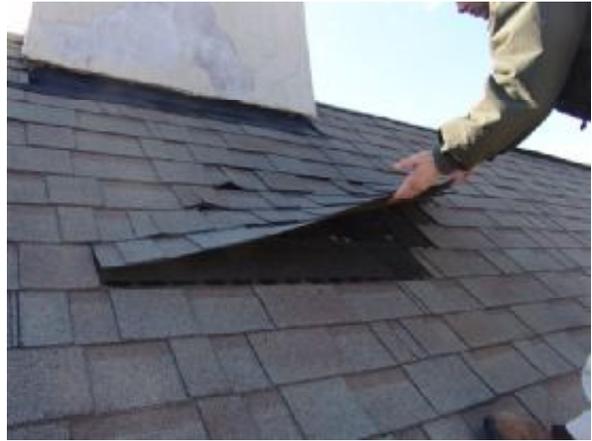
Photographs 25 & 26 – Over-driven nails have allowed this group of shingles to “slide” down the roof, creating the wrinkle highlighted by the arrow. The entire group of shingles was loose and ready to be blown off by an otherwise non-destructive wind.

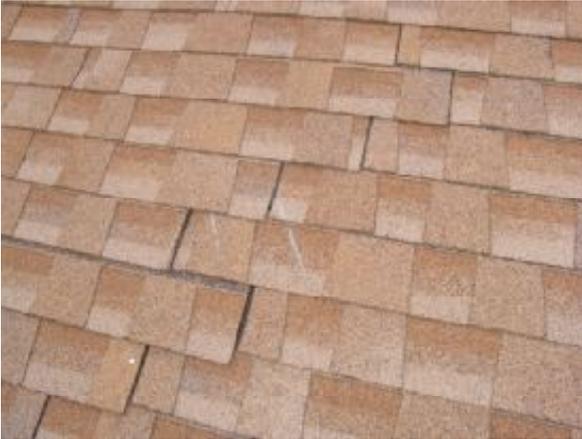
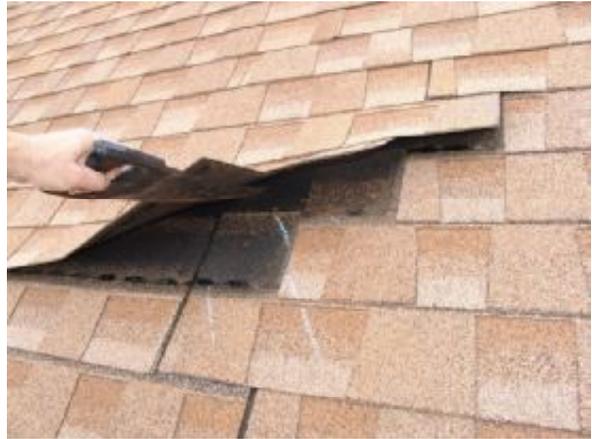
Photographs 27 & 28 – A stair-stepping crack through a shingle roof that widens from top to bottom is an indication of shingle sliding. The condition is a consequence of over-driven nails yet is often improperly blamed on wind, although it justifiably does create a roof that is easily damaged by wind.

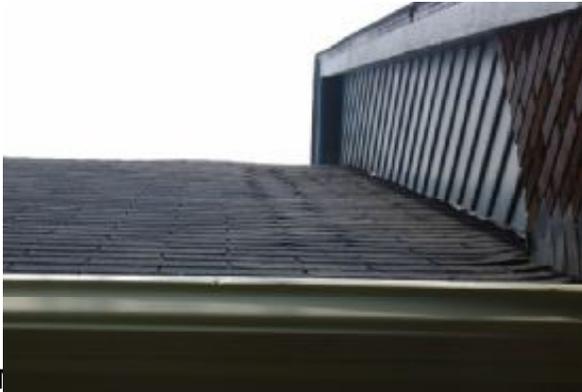
Photograph 29 - Lines of wrinkles in a roof are an indication of shingle sliding. In this instance, it was caused by both over-driven nails and an insufficient number of nails being installed through each shingle. It is not related to wind, although it was originally blamed on wind.

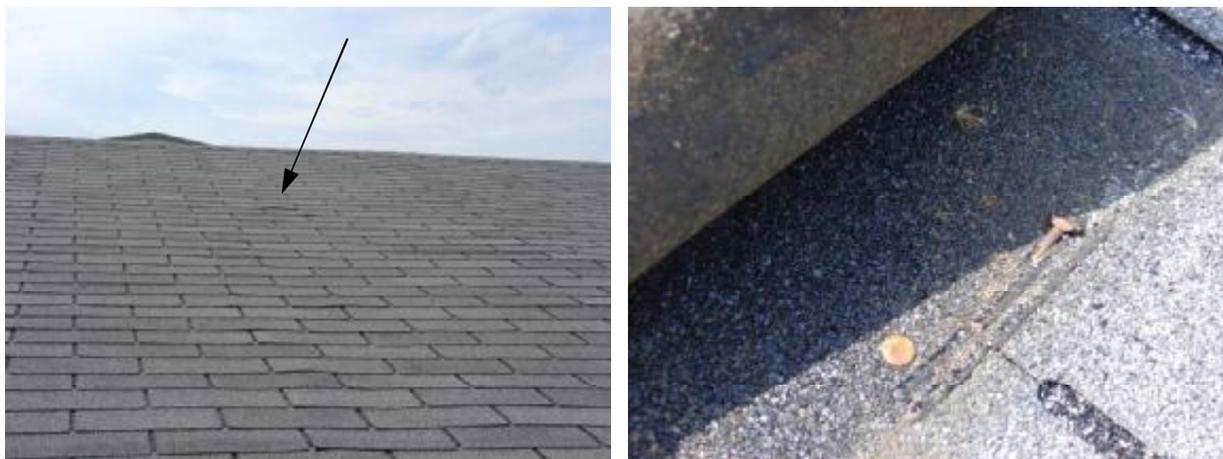
Photographs 30 & 31 – While not yet blown off, this crooked nail simply bent over by a lazy installer has made this shingle inherently prone to damage from wind.

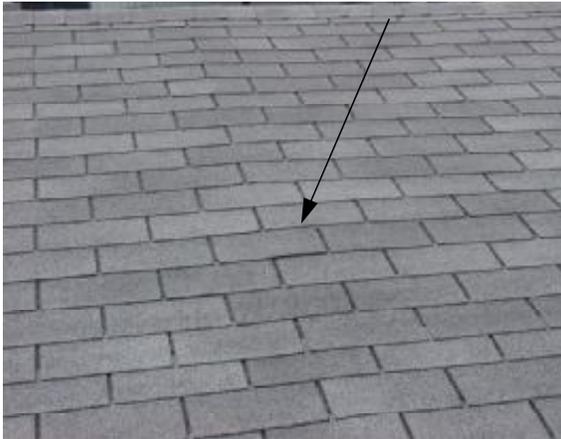
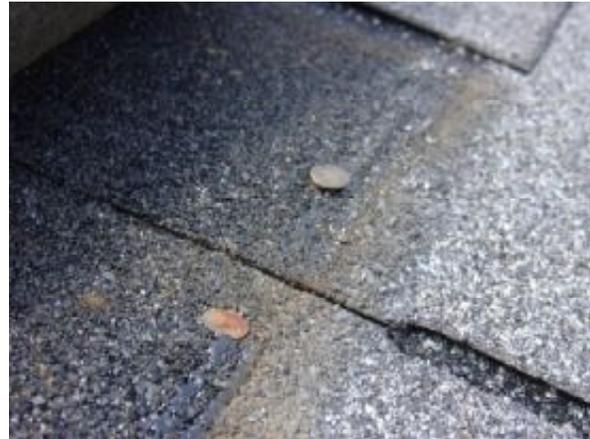
Photographs 32 & 33 – A common nail pop creating a shingle tab that is inherently susceptible to damage from otherwise undamaging winds.

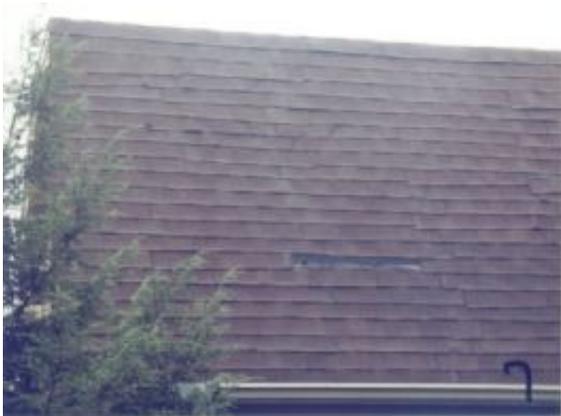
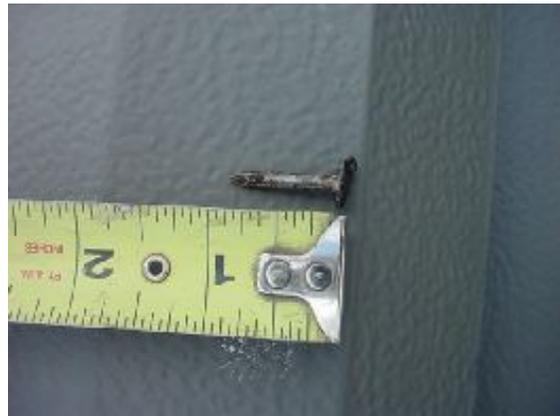
Photographs 34 & 35 – This nearly brand new roof was severely damaged in a routine summer thunderstorm because the contractor failed to use enough nails, failed to hand seal shingles on the steep slopes of this roof, and used nails with a smooth shank that were clearly too short for this application.

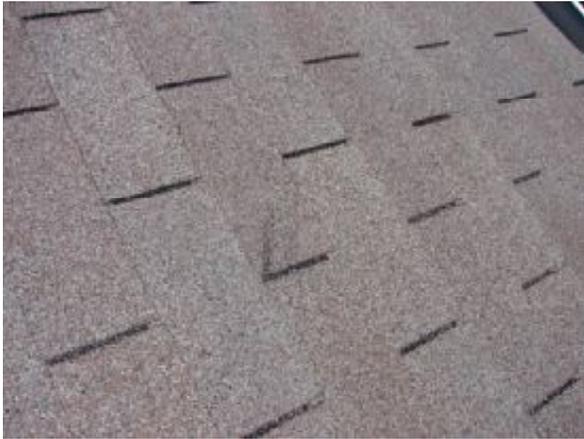
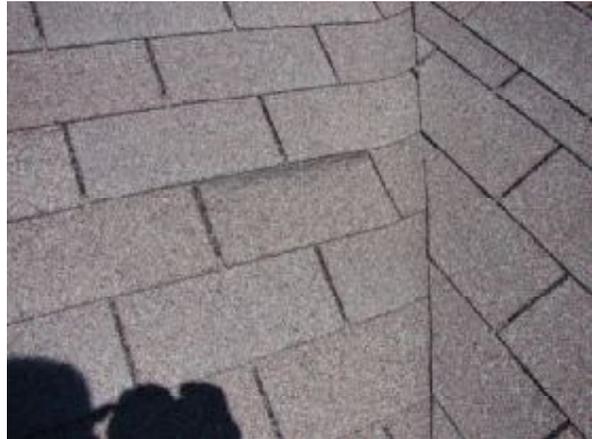
Photographs 36 & 37 – A diagonal crease through the keyway to the butt edge of a shingle is indicative of wind damage made possible because the corner area of the shingle did not seal down properly as designed. A horizontal crease across the top third of a shingle tab indicates that the entire seal strip failed to adhere as designed.

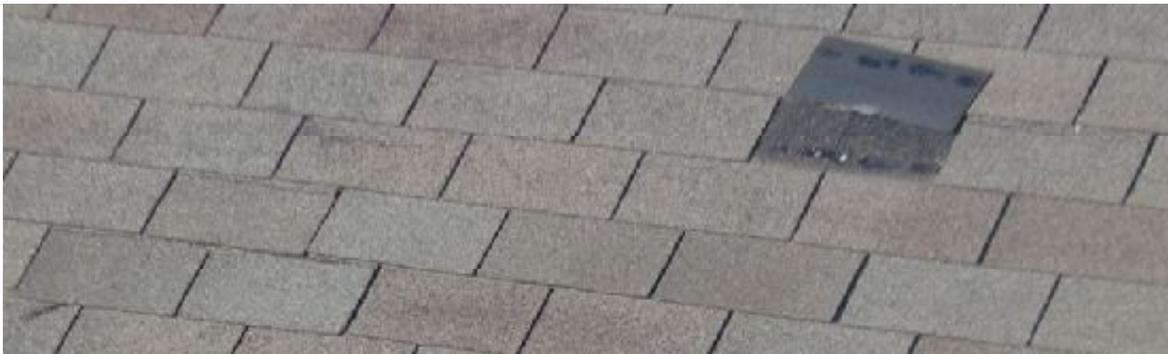
Photograph 38 – Both creased and torn shingle tabs are visible. Note, the torn and broken-back tab exposes nails improperly installed through the asphalt seal strip, which were found throughout this roof and are the proximate cause of this loss.

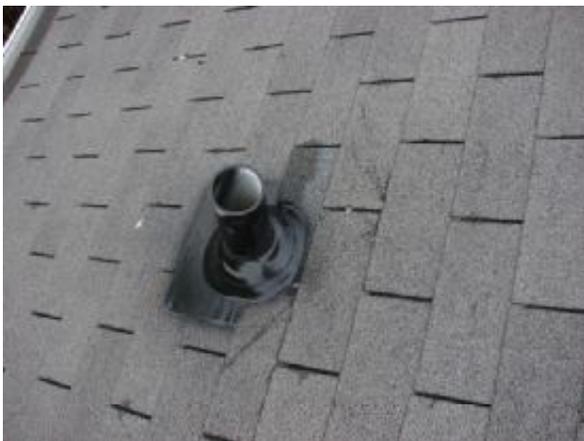
Photograph 39 – Valid wind damages commonly occur around roof penetrations where shingles lay on top of flashing, versus an underlying shingle with a seal strip keeping the two held down together. The proximate cause of this loss is a human error, as these shingles should have been hand sealed to the flashing. Nonetheless, it is a valid wind loss. Another potential cause may be shingle abuse from the installation of the plumbing vent. However, since wind cannot be ruled out and because the damages are consistent with wind, wind damage is a valid position.

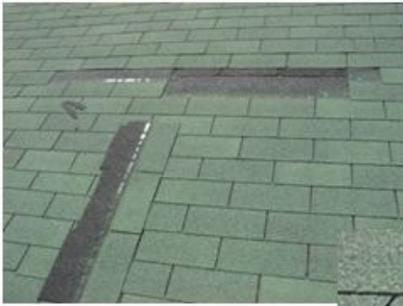
In these areas, the smooth and slick texture and reflective appearance indicates that the sealant strip failed to adhere as designed.

Photographs 40 & 41 – A roof that has sustained valid wind damage. Closer study illustrates the proximate cause was only partial adhesion of the asphalt seal strips. Large areas of effected shingles were entirely unsealed, whereas small sections were lightly sealed, and sporadic areas were sealed as designed as indicated by shingle delamination.

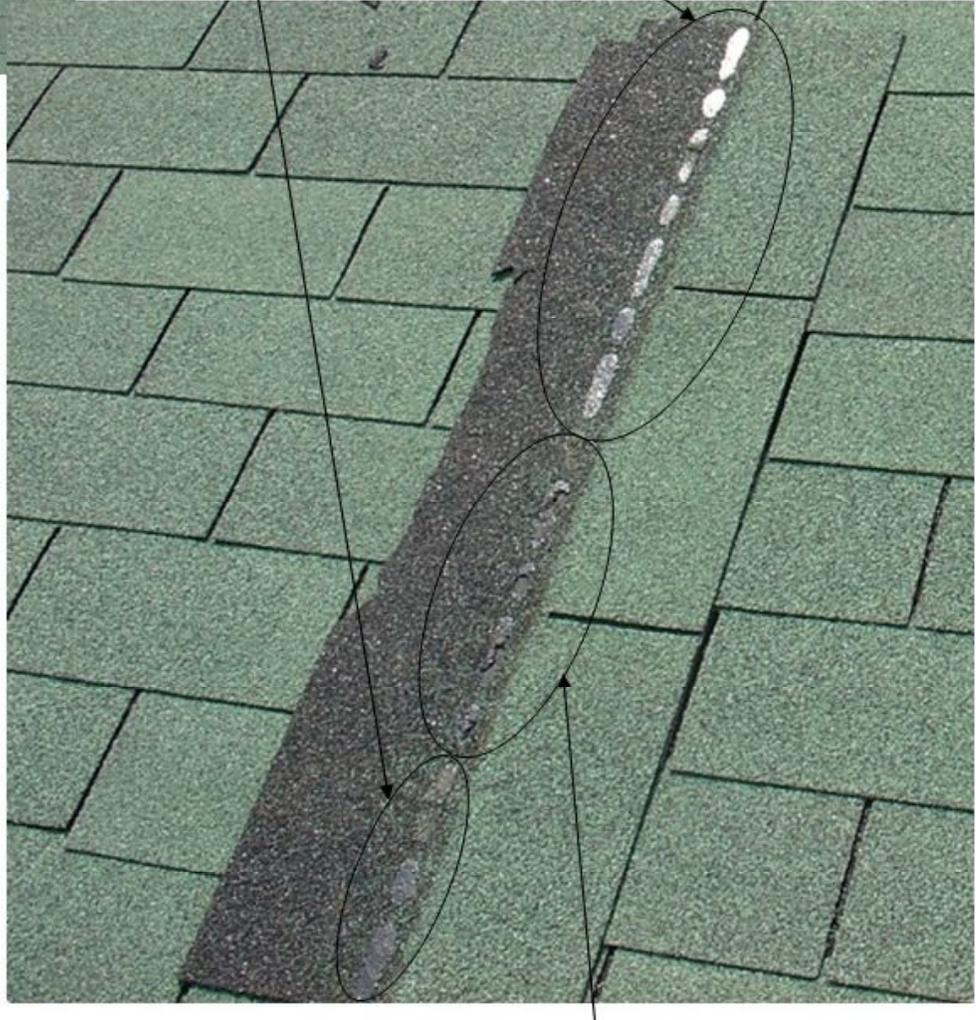
In this area, the shingle physically delaminated when it was torn from the roof by wind. This delamination indicates that, at least in this area, the shingle's sealant strip reached a design level of adhesion.

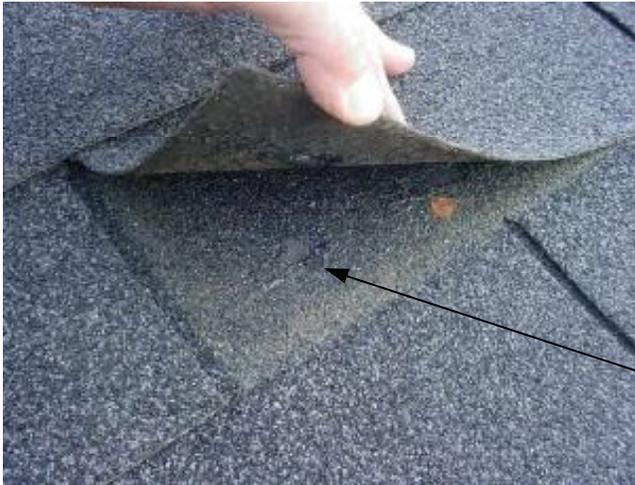
Photograph 42 – The majority of this shingle failed to seal as designed. However, the delamination confirms that it was at one time adhered properly in a small spot, and therefore a claim of wind damage is supported.

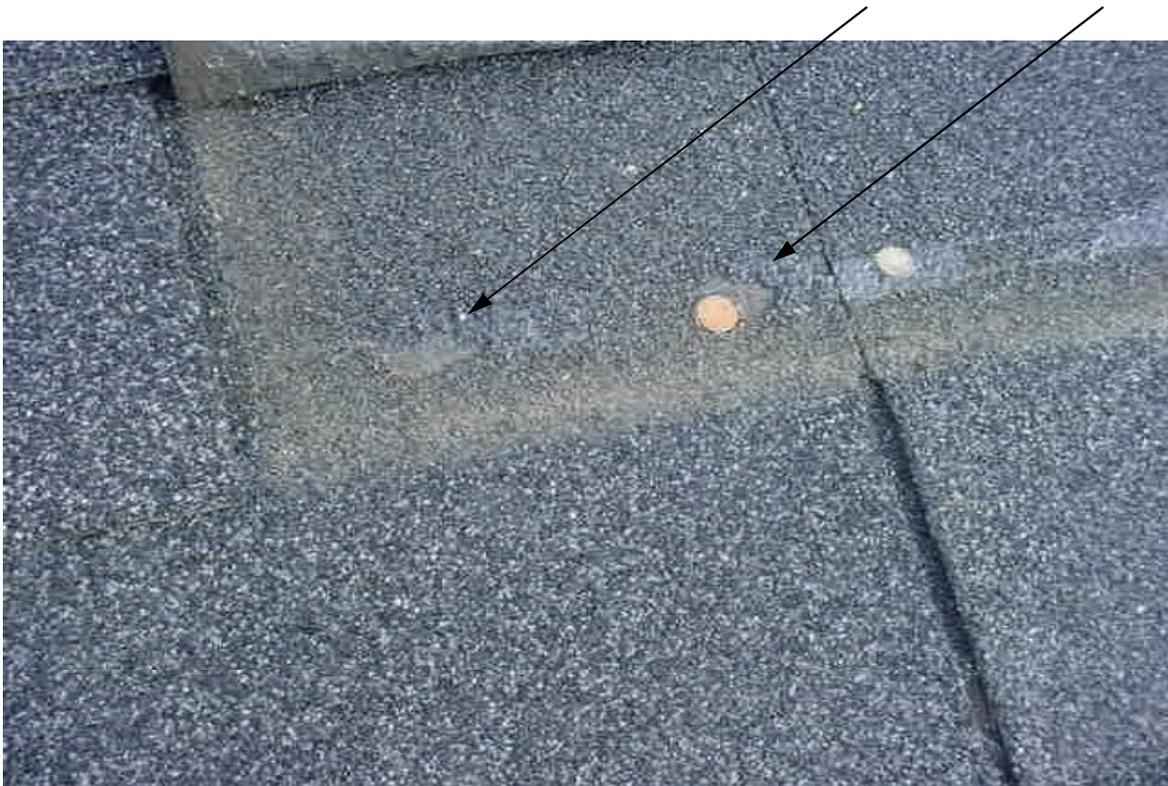
Photograph 43 – The uplifted shingle in this photograph was overwhelmingly unsealed. However, since a few spots adhered as designed and delaminated when pulled apart, regardless of creasing or tearing, a position of wind being the cause of loss cannot be overruled.

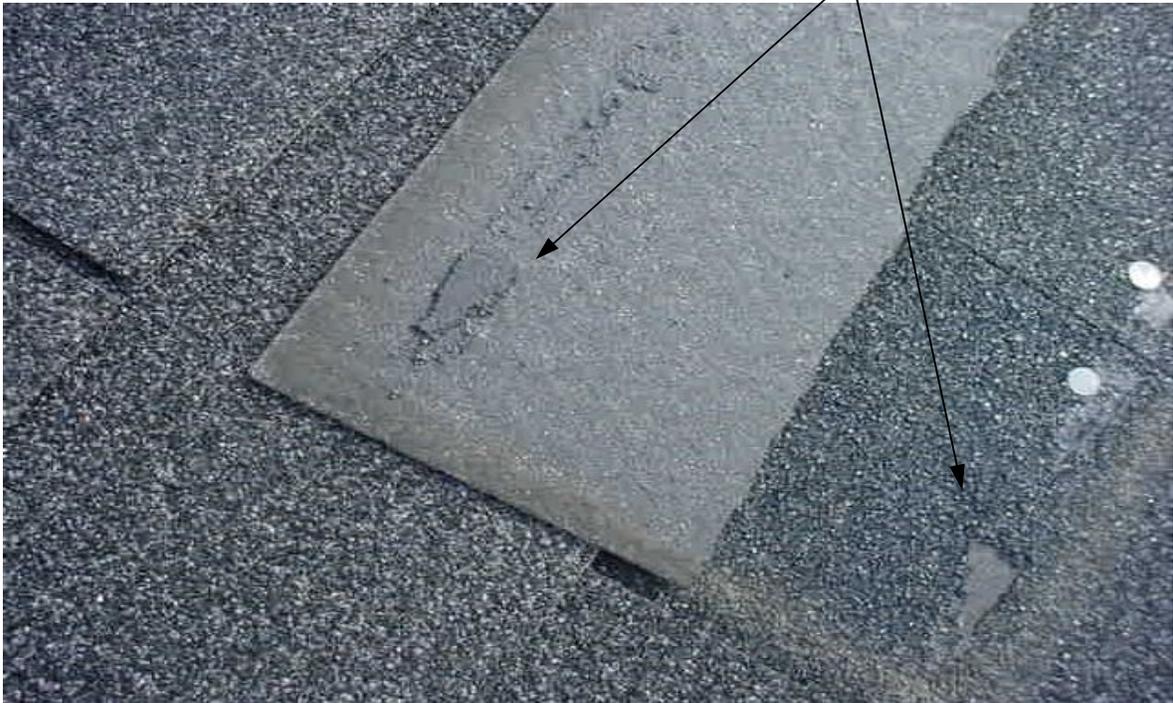
Photograph 44 – An example of isolated shingle delamination along a seal strip. Although the remainder of the tab never sealed, because this area did, a claim of wind damage is validated even if the shingle wasn't torn.

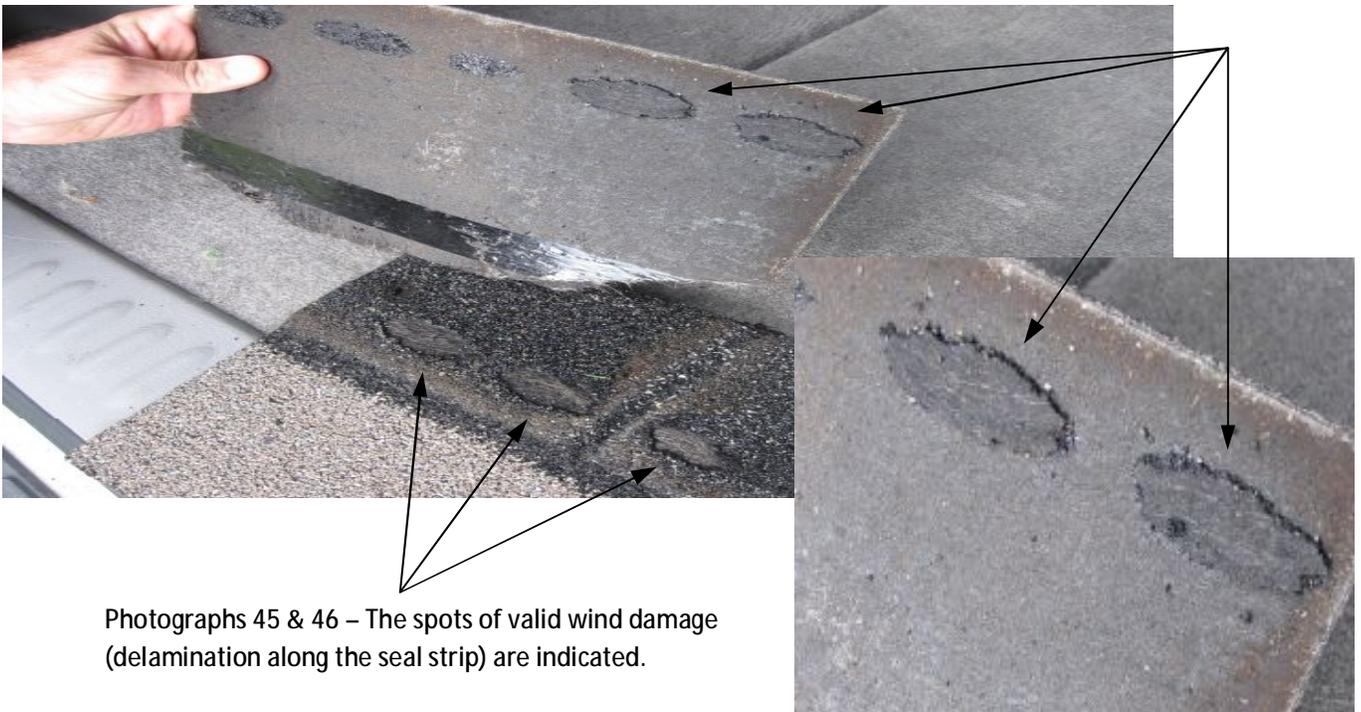
Photographs 45 & 46 – The spots of valid wind damage (delamination along the seal strip) are indicated.

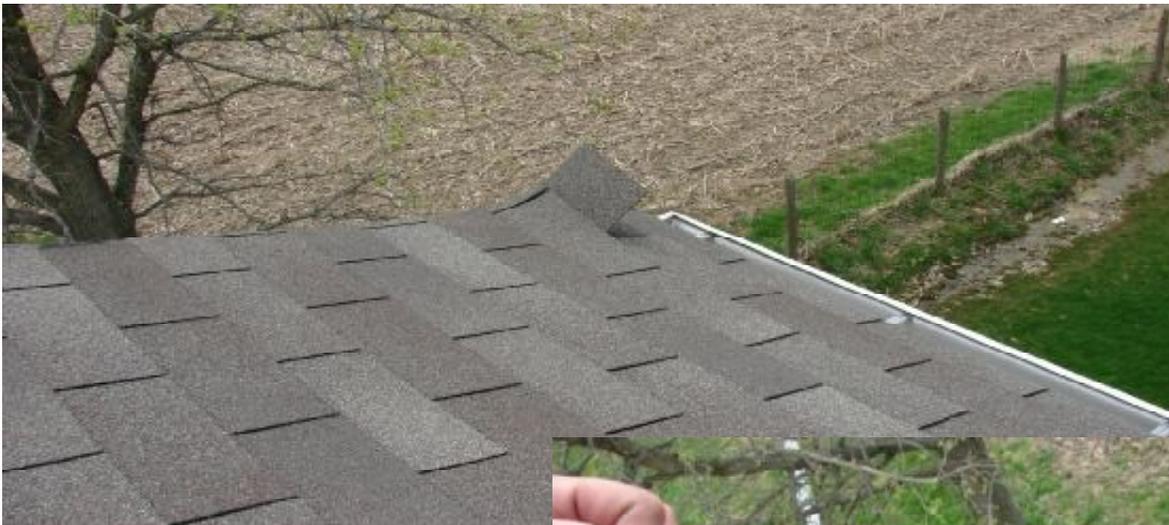
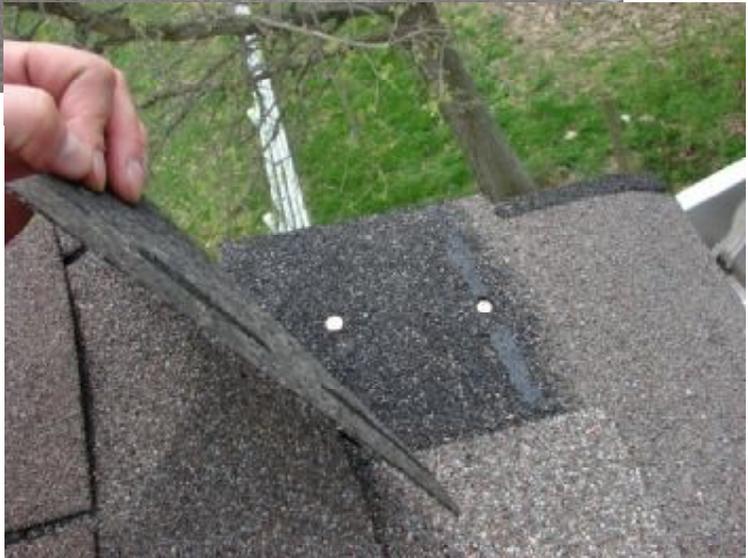
Photographs 47 & 48 – This new roof was studied on a windy day when strong but far from severe winds were flapping loose shingles around the rakes, corners, and eaves of this roof. However, the shingles were not creased, torn, or delaminated; therefore, although wind is lifting the shingles, wind has not damaged the shingles. There’s been no direct physical loss from wind...yet. The proximate cause of this condition is not wind, but over-driven nails that were also high nailed. If left uncorrected, valid wind damages are inevitable.

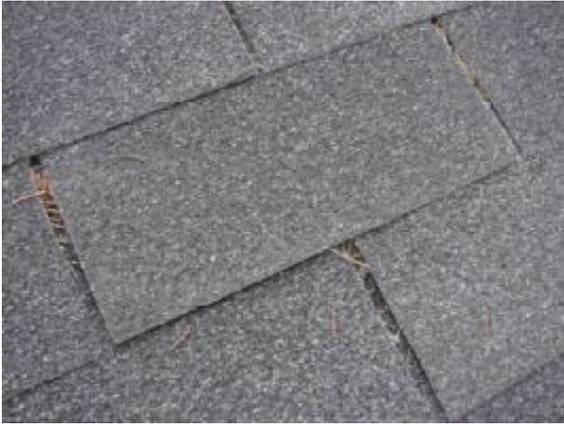
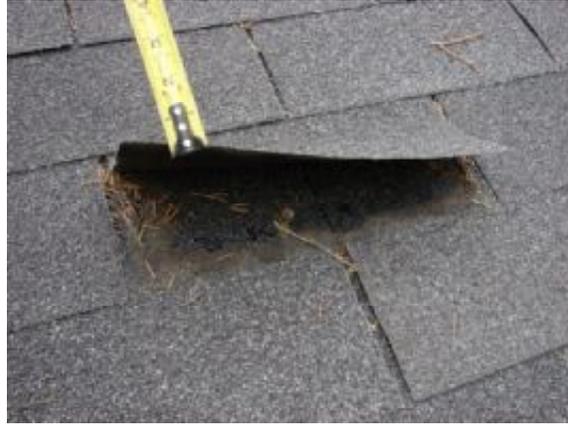
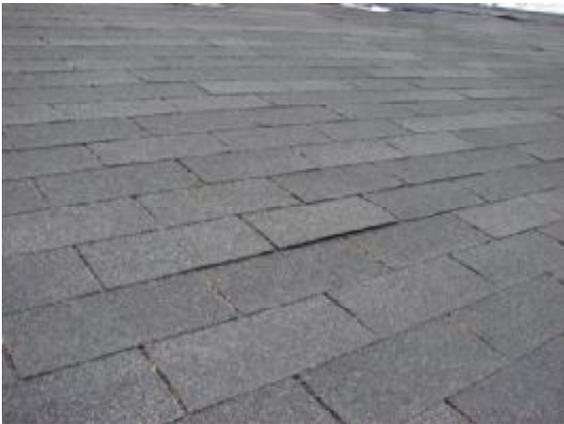
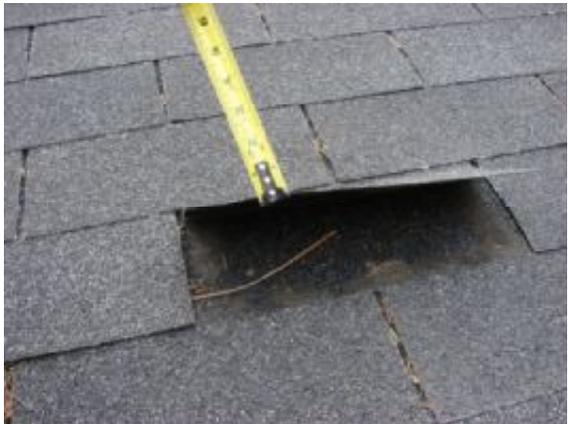
Photographs 49 - 52 – Classic examples of shingles that have been lifted by wind and are no longer lying flat, yet they are not “wind damaged.” The shingles were lifted by wind without being torn, creased, or without delaminating the seal strip. Therefore, they were loose before, and even though they are now uplifted from windborne debris, they have not yet sustained a direct physical loss (damage). They can be properly repaired by removing the debris and hand sealing, or they can be left in place to be soon validly damaged by wind.

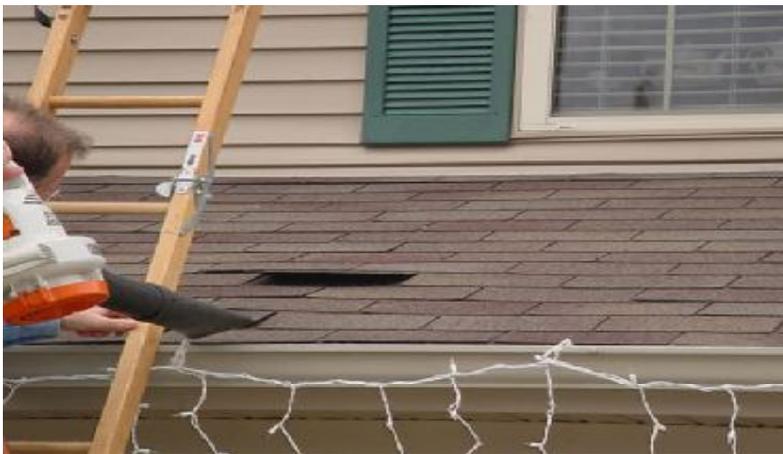
Photograph 53 – A leaf blower is being used to illustrate the phenomenon where wind uplifts a previously loose shingle and yet no damage is caused.
