Self-Sealing Asphalt Shingles – Technical Bulletin 3.0

Is My Roof Wind Damaged? Is Wind the Proximate Cause?

A Guide to the Various Stages of Wind Damage to Residential Asphalt Shingle Roofs and Repair Options for Each Stage

FORENSIC ENGINEERING & FIRE INVESTIGATION

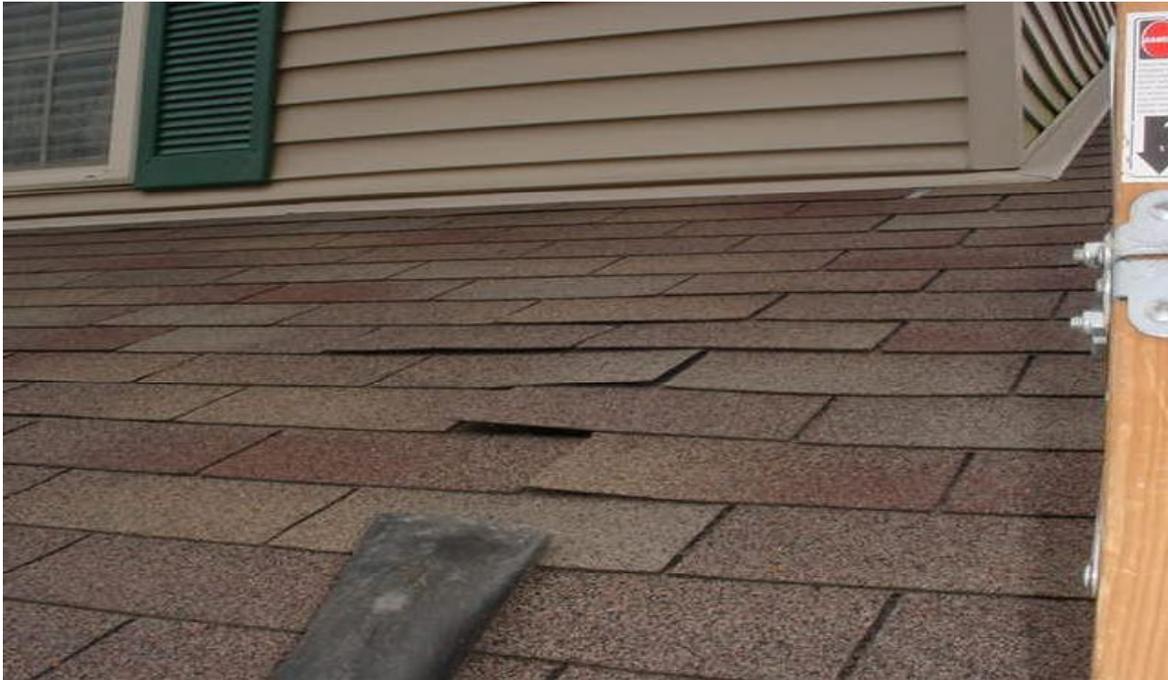
Photograph 54 – A leaf blower being used to highlight shingles that were previously unsealed, yet the lack of proper adhesion was previously unknown. The shingles in this example are not being damaged by wind, but are certainly prone to future damages from otherwise non-damaging winds.
