PROBLEMS WITH CODE-COMPLIANT BRICK VENEER IN RESIDENTIAL CONSTRUCTION

Derek A. Hodgin, RRO, RRC, RWC, PE, CDI Construction Science and Engineering, Inc. Westminster, SC

Problems With Code-Compliant Brick Veneer in Residential Construction

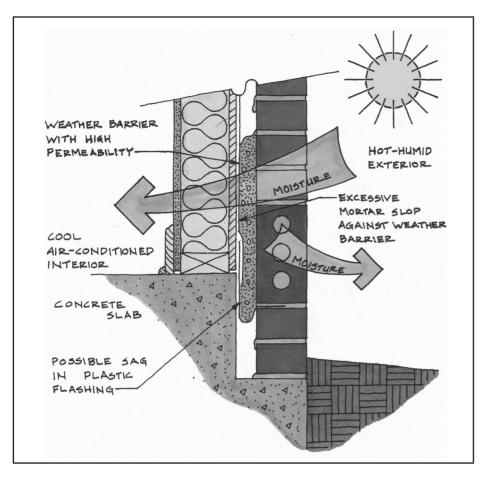
Figure 1

Even though this article is written specifically for residential construction problems, it is worth noting an inconsistency regarding the use of weather-resistant membranes that exists between the International Residential Code (IRC) and The IBC does not make exceptions to this requirement. The inconsistency between the two codes suggests that somehow water behaves differently on commercial and residential buildings. Unfortunately, the reality is that water has the potential to cause damage to all buildings, regardless of their type.
